BUILDING ASSESSMENT

NEWTON PUBLIC LIBRARY

720 North Oak
Newton, Kansas 67410

May 2008

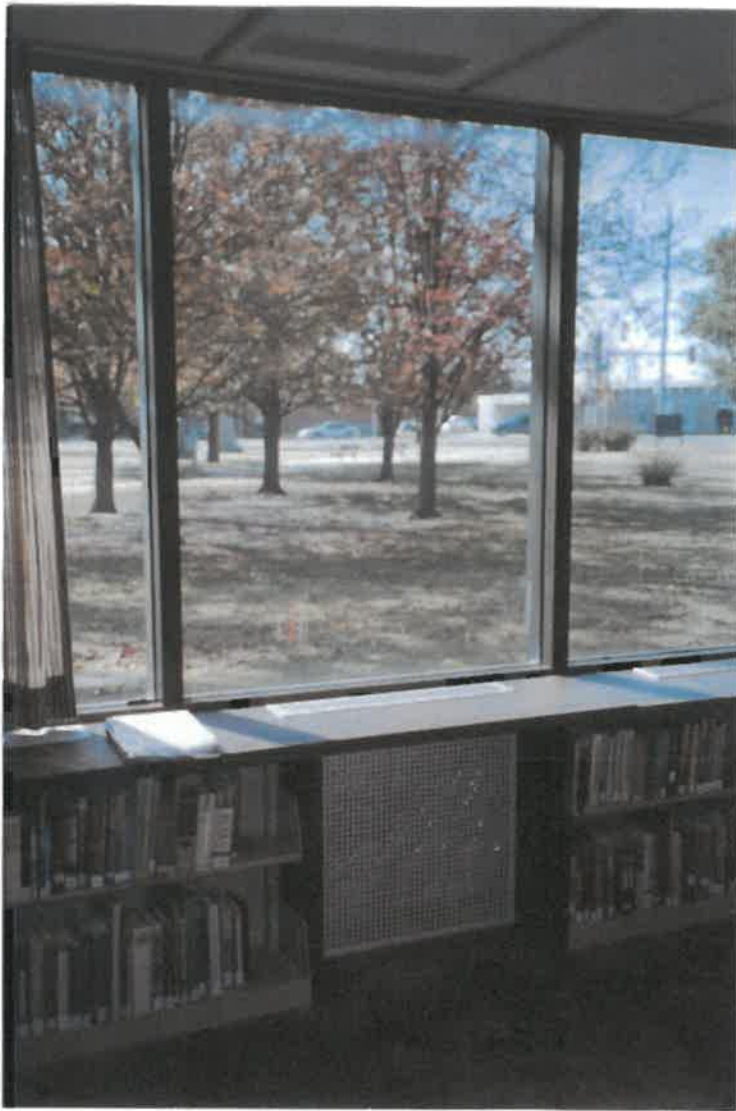
- 1.1.2 Numerous glazing gaskets exhibit deterioration, displacement, and wear.
- 1.1.3 At the original building, there are no overhangs to shade windows. Considerable energy loss occurs through non-insulating glass, and through minimally insulated glass spandrel panels. During cold weather, considerable heat loss occurs and condensation occurs on the interior of the glass causing library occupants to experience discomfort when near these window units. (See Section 4 of this report.) During hot weather, and at times when direct sunlight strikes the windows, excessive heat gain is experienced. In the 1980 addition, seals on several large double-glazed, insulated windows appear to have been broken.

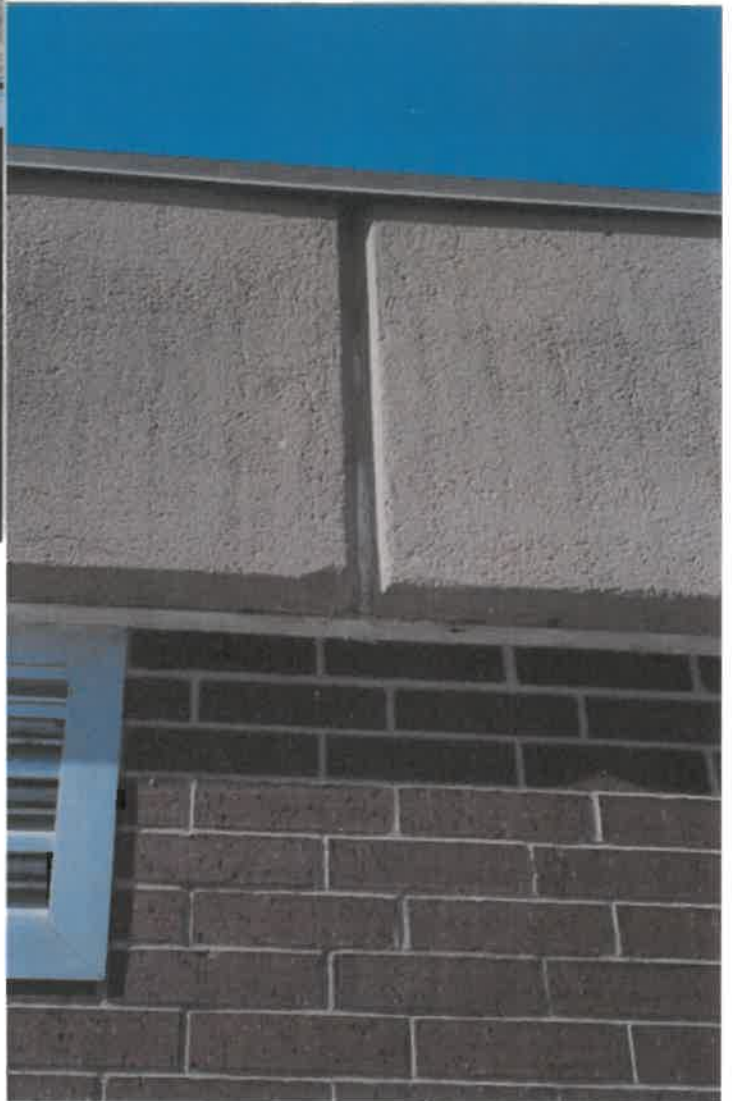
- 1.1.6 Movement of precast concrete fascia units and columns has opened joints between many of the units. Openings in joints between the fascia, columns, and adjacent masonry walls is also evident. Sealant has apparently been applied in the past to seal joint openings. However, there are locations currently in need of repair.

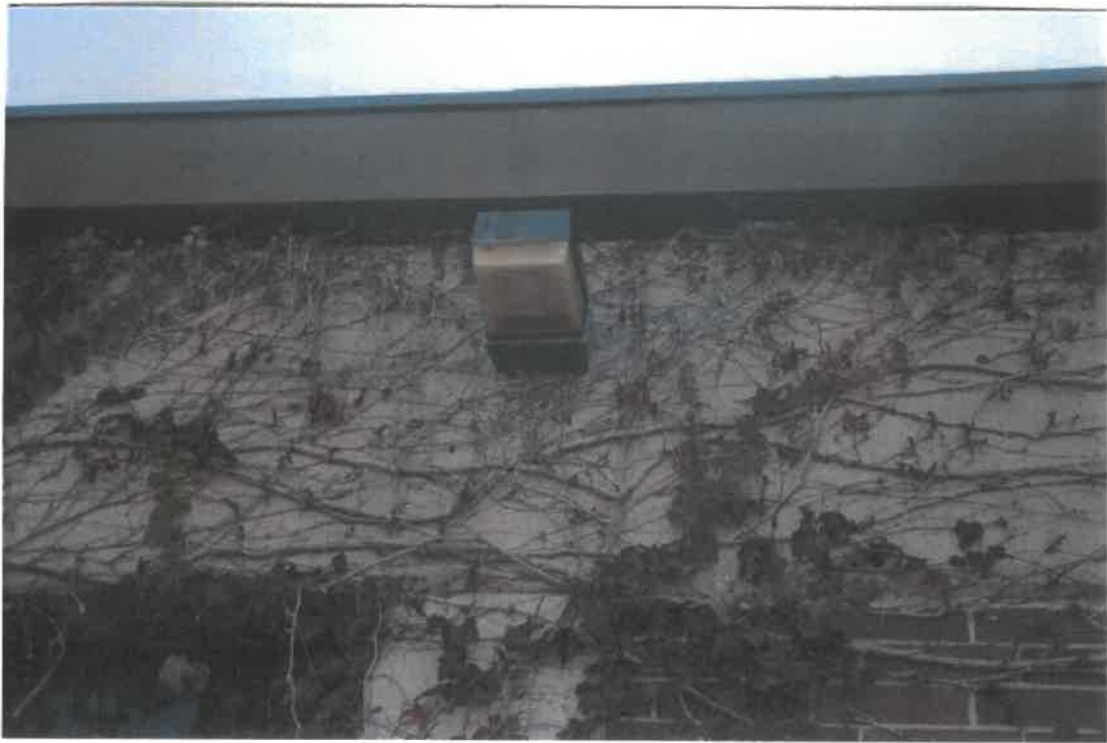
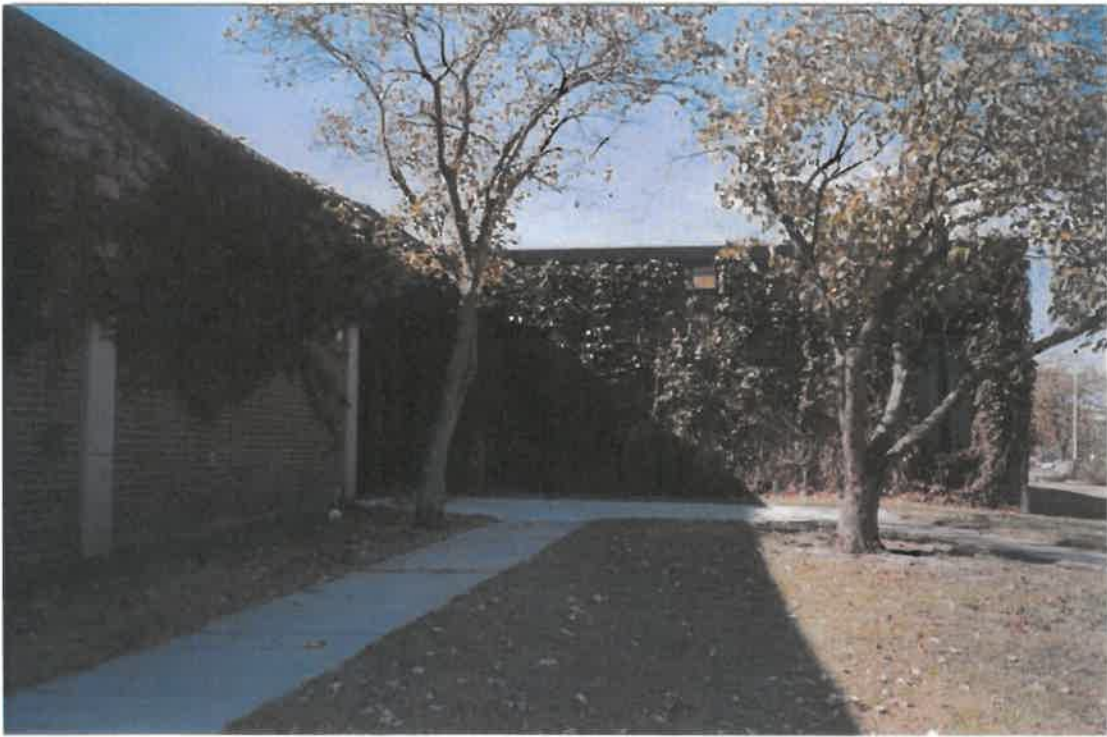
- 1.1.4 Steel angle lintels, where exposed on the exterior, exhibit rust accumulation.
- 1.1.5 On the 1980 addition, vines have been allowed to grow over several masonry walls, precast concrete columns, fascias, and window screens.

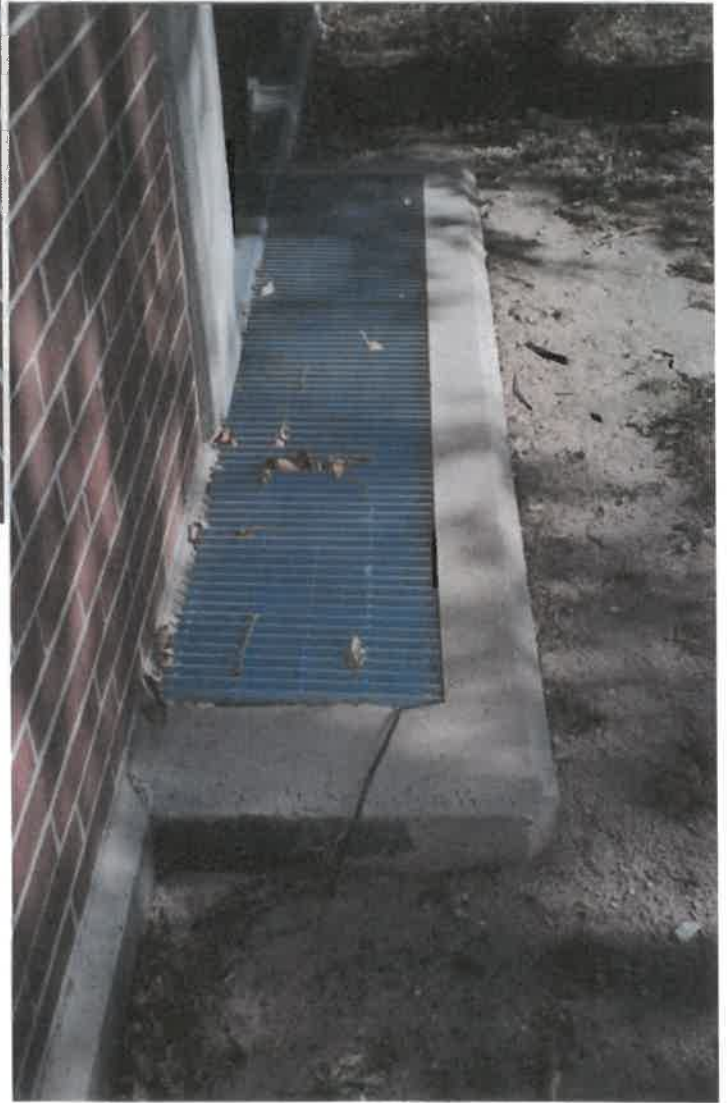
- 1.1.9 Sealant damage and deterioration at the basement wall louver in the south areaway has occurred. The areaway contains trash. An exposed cable runs into

the areaway from underground. Furthermore, the grating over the areaway is not secured and can be lifted, creating a potential safety hazard.

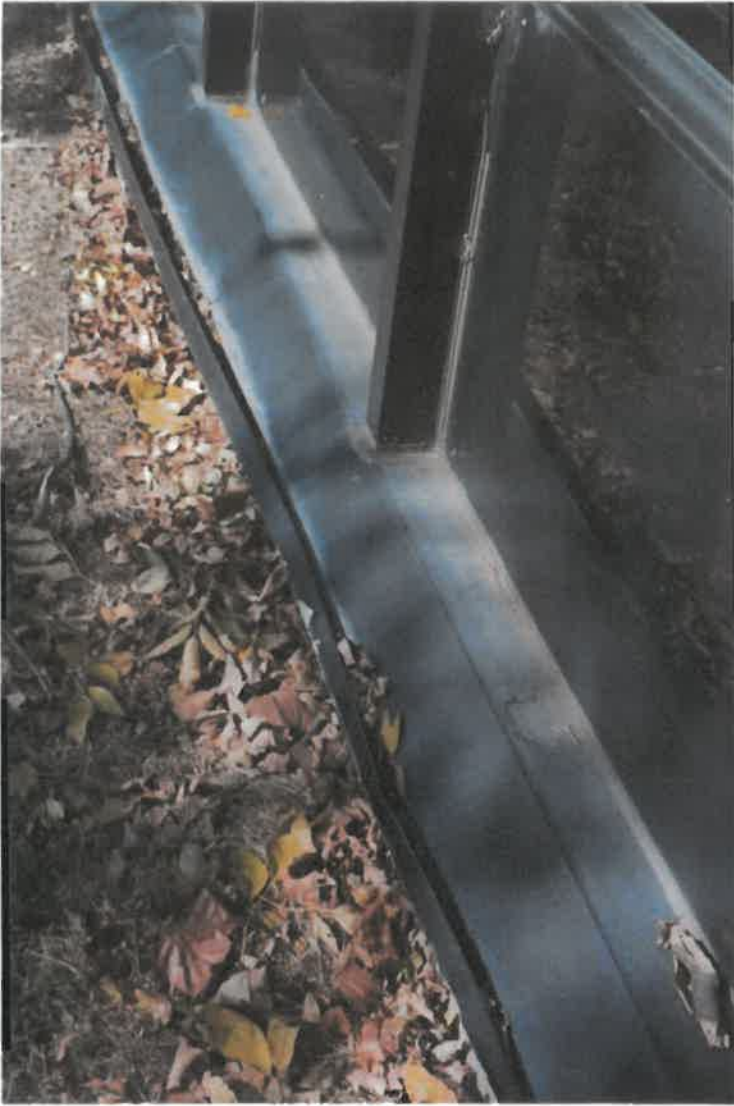
- 1.1.7 Attempts have been made in the past to address drainage problems and leaks along the south window wall by the addition of metal sills.
- 1.1.8 Metal fascia alterations have apparently been made in the past, and gutters and downspouts added, to facilitate roof drainage. There is evidence that some roof overflow has occurred. The ground surface appears to slope towards the building perimeter in several areas, causing surface water to flow against the foundation, and in some cases up to the bottom of the aluminum framed window units.

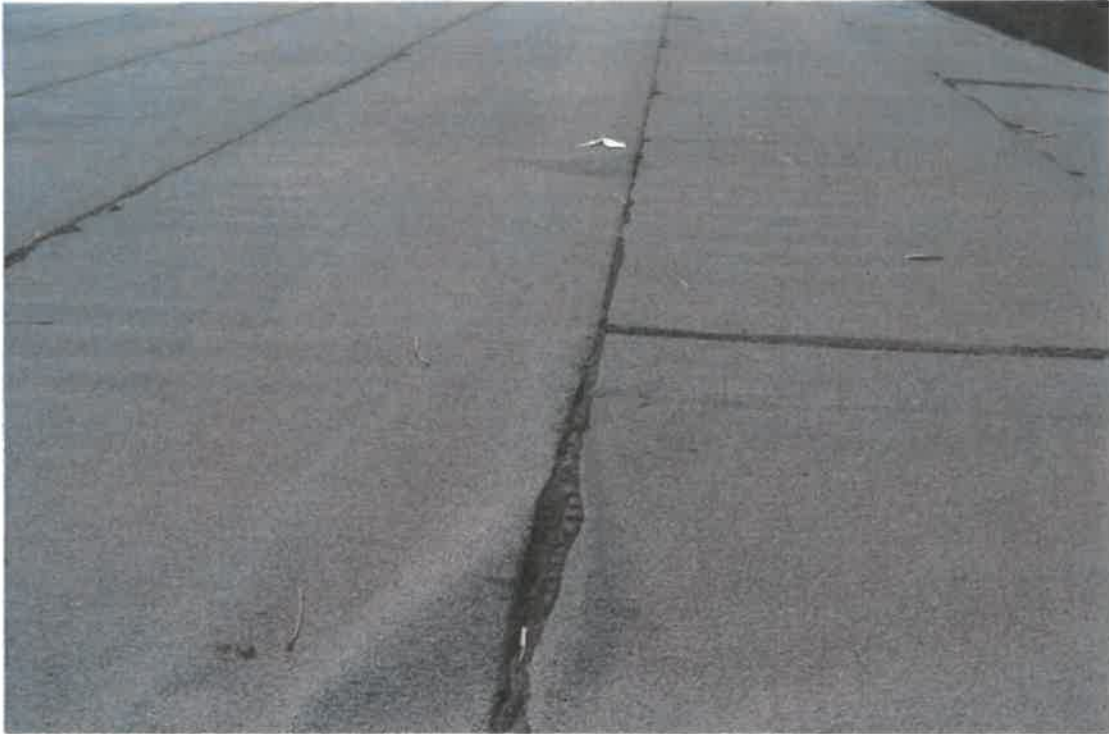
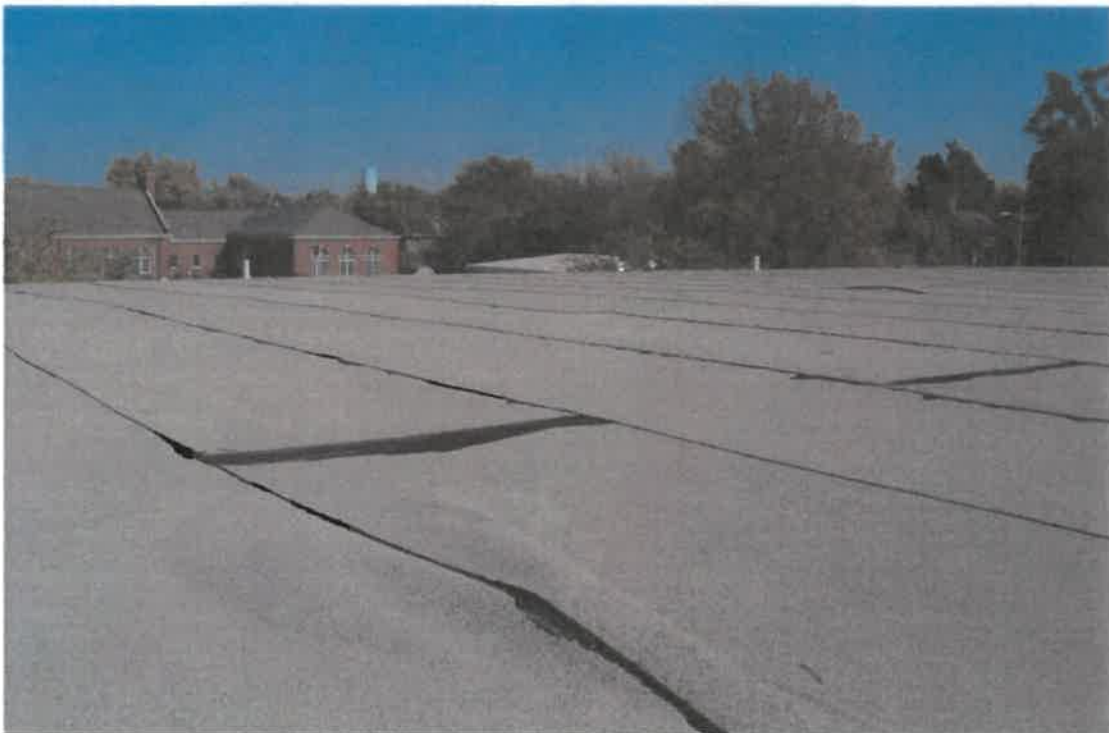
1.25

- 1.2.5 The roof over the building addition is in very poor condition. Bubbles in the roofing membrane are numerous and severe. Some joints in the roofing membrane are being pulled apart by the bubbles. Although not visible without cutting through the roof membrane, roof insulation has likely been damaged by moisture. At roof-mounted equipment, patches have aged and bituminous patching material is cracked and pulling up the surface of the roofing. Caulking repairs have been made to some of the roof penetrations.

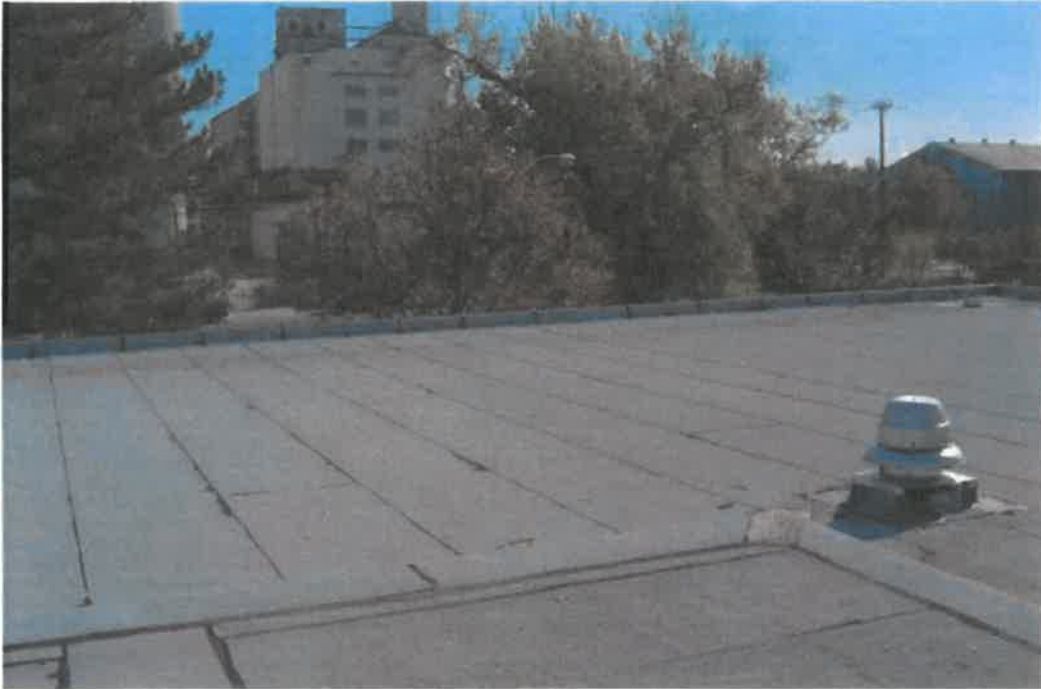
- 4.2.1. The exhaust fan EF#1 serves the first floor restroom, janitor's closet and receiving. The exhaust fan has far exceeded its expected useful life and should be replaced.

4.1.1.2.1. - EF#1 Exhaust Fan - View 1870

4.1.1.2.1. The exhaust fan should be replaced.

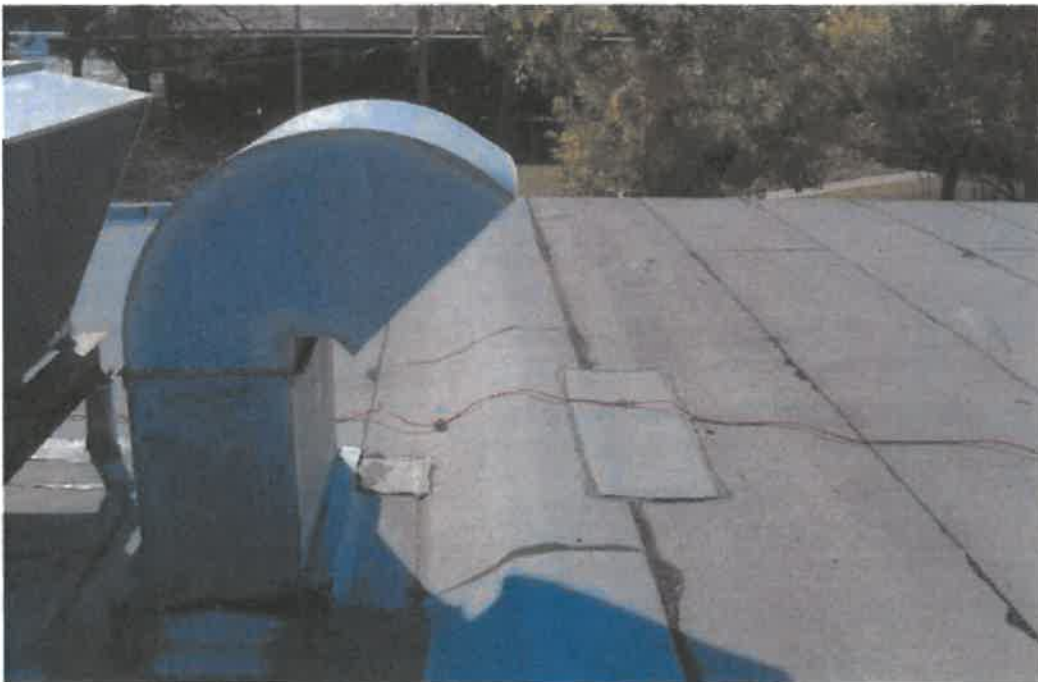
4.1.1.3. - Fresh Air Intake Hood - View 1897

4.1.1.3. The fresh air intake hood should be modified to reduce moisture intake with the fresh air.

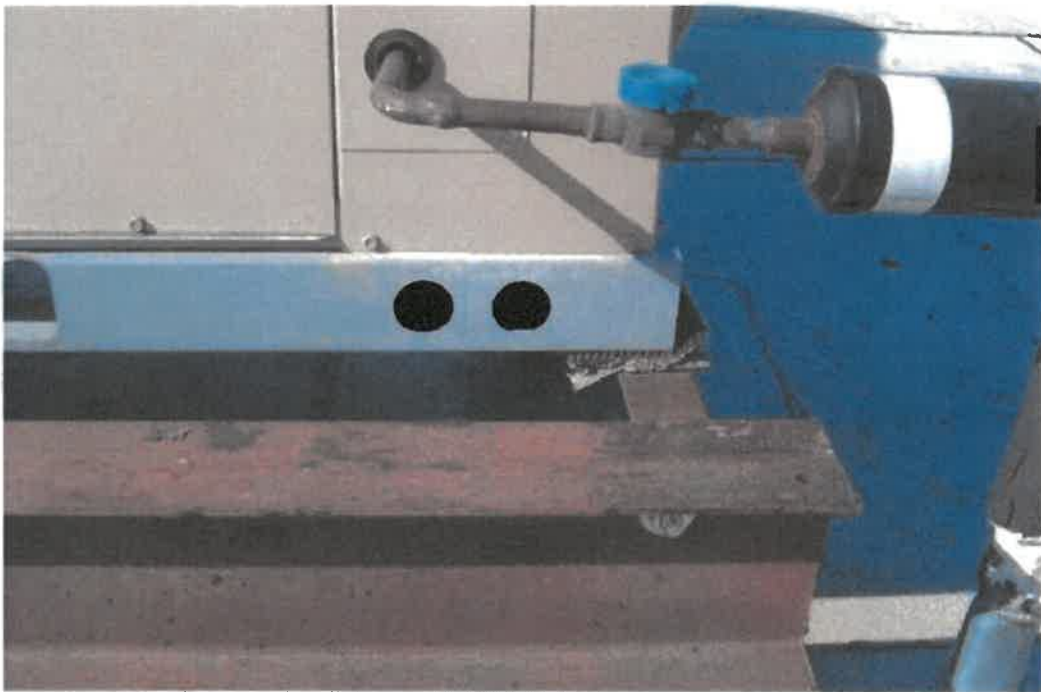
4.1.1.5.1.2. The vibration isolation pads are in a much deteriorated condition and should be replaced.

4.1.1.5.1.2. – Replace Isolation Pads - Unit#1 – View #1879

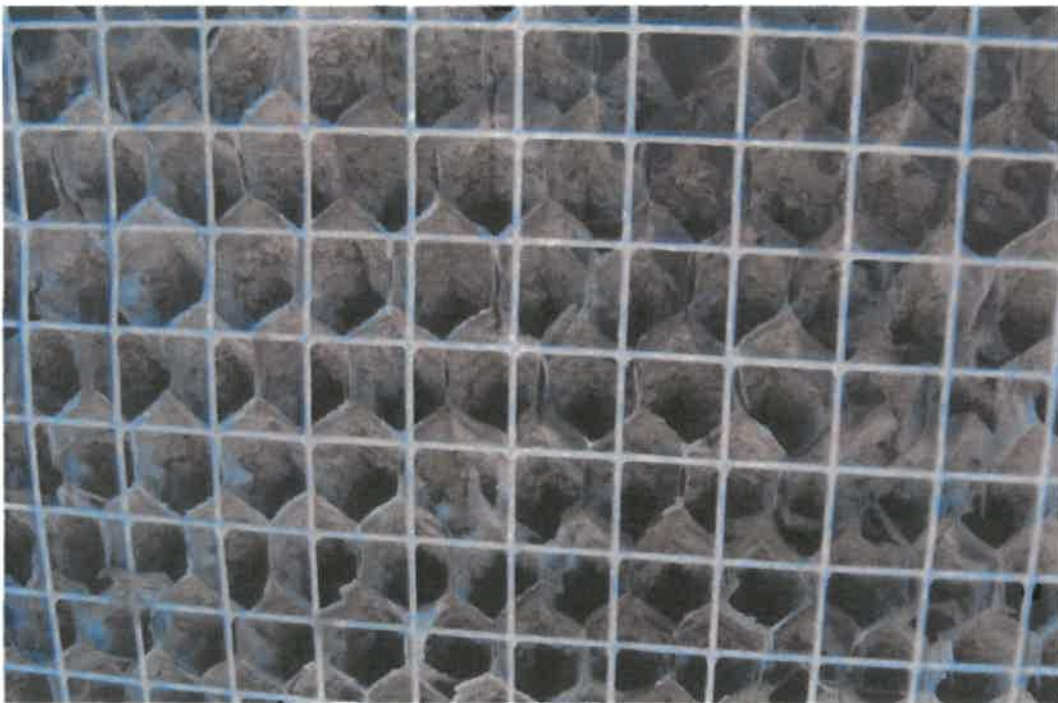
- 4.1.1.7.1. The condenser water piping has exterior surface rust; however, failure of the piping will occur in most cases from the inside out.
 - 4.1.1.7.2. The interior of the piping could not be observed, however, the tower fill was observed. The tower fill showed signs of very heavy fouling in the recent past. This raised concerns of Legionella, however, maintenance personnel indicated the situation was now under control.

4.1.1.7.2. Cooling Tower Fill - View 1856

- 4.1.1.7.2.1. An aggressive approach to water treatment should continue to give reasonable assurance that an excessive Legionella infestation will not occur. This will also give the best probability of getting the full useful life from the tower, because a chemically dirty and biologically active tower is also more subject to corrosion.

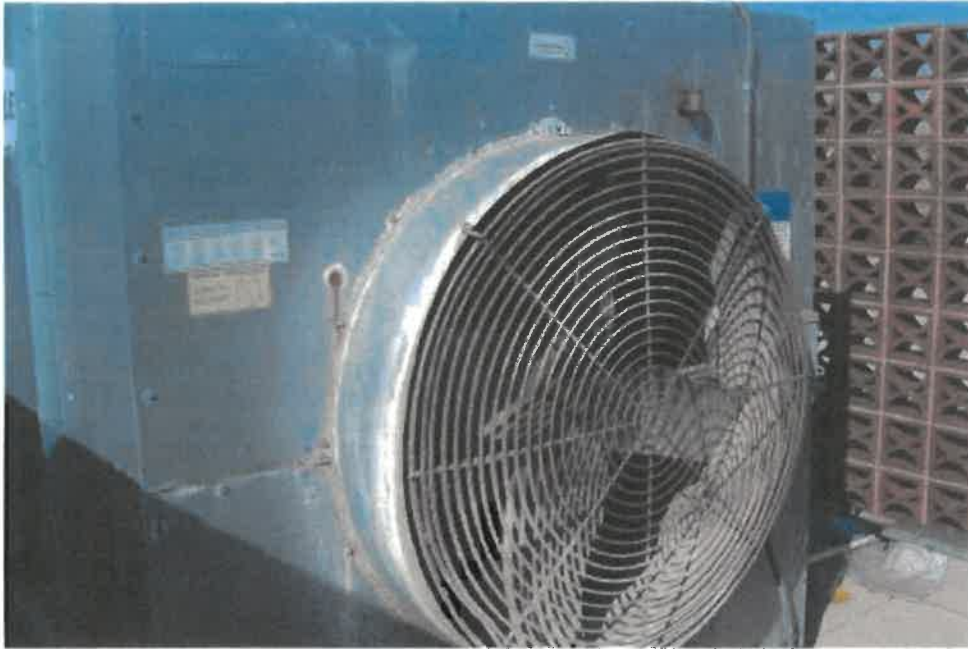
- 4.1.1.6.1.2.1. The seal of the roof penetration of the refrigerant piping has deteriorated and should be repaired or replaced.
- 4.1.1.7. The cooling tower shows signs of deterioration. It is 13 years old and has an expected useful life of about 15 years.

4.1.1.8. Cooling Tower – View 1844

- 4.1.1.8. Budgeting for tower replacement in two or three years is recommended. As noted in the water treatment, it may be possible to extend the tower life a couple years more than expected with careful watching of the tower treatment. At the time of tower replacement the piping should be carefully checked for level of interior corrosion with selective destructive testing. Total pipe replacement may be needed.

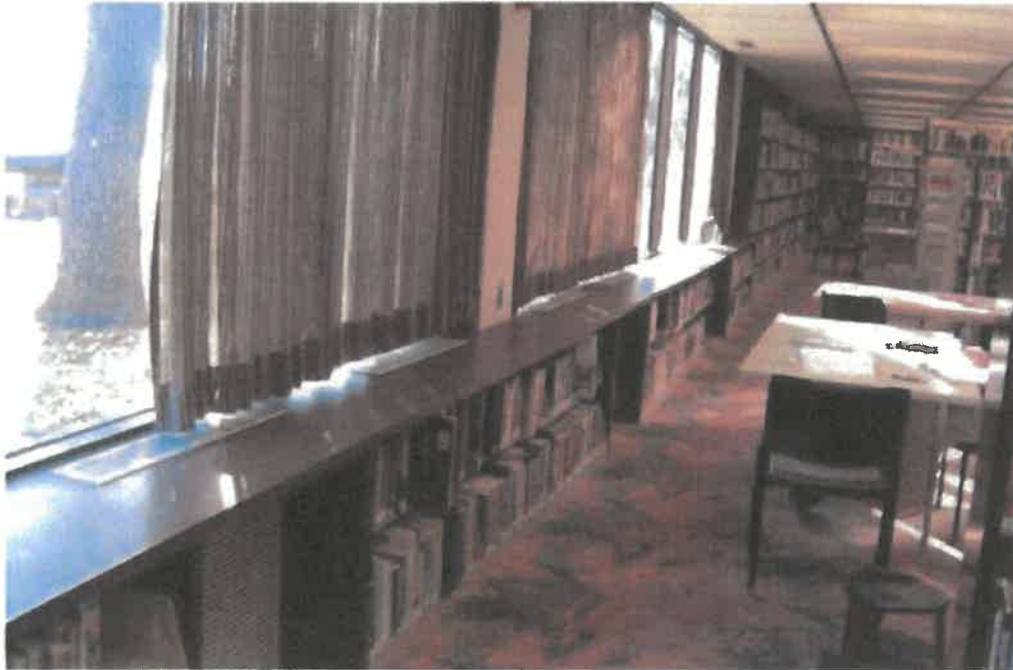
4.2.3.2. Fin-Tube Window Heat – View 2060

- 4.2.3. Condensation occurs on some of the windows in cold weather, which poses a maintenance problem. One method of solving the problem is to keep the humidity level above the dew-point temperature of the cold surfaces. Most humidification systems have difficulty holding the relative humidity at the proper set-point or adjusting the set-point to compensate for the lower dew-point when outside temperatures are lower. This can be done with proper controls and/or appropriate heat sources for warming the cold surfaces.

- 4.2.3.2.1. It is recommended that the air system be modified to move additional air down the windows to increase the interior surface temperature of the new windows.

- 4.2.3.2.2. Also, it is recommended that the control system be modified to automatically reset the relative humidity level to a safe set-point based on the outside air temperature.

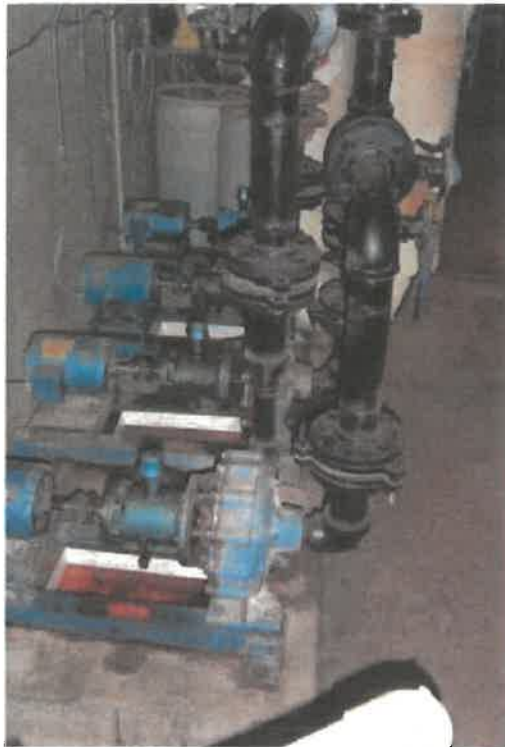
- 4.3.6. The building hot water heating and chilled water pumps appear to be the original pumps. They are well beyond their expected service life and they should be replaced with new units for greater reliability and for ease of getting new parts.

4.3.5. Hot & Chilled Water Pumps – View 1996-1

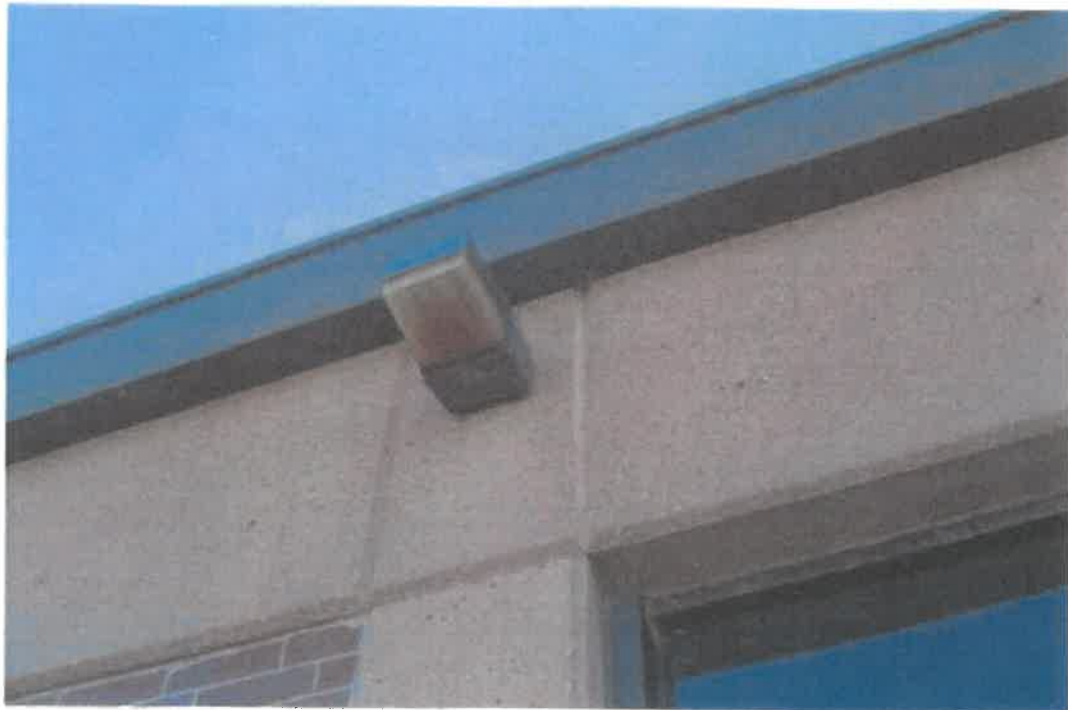
6.3.1. Outside light fixtures are in need of cleaning and/or repair to allow the light fixtures to perform their intended functions.

6.3.1. Exterior Light Fixture - View 1940-1

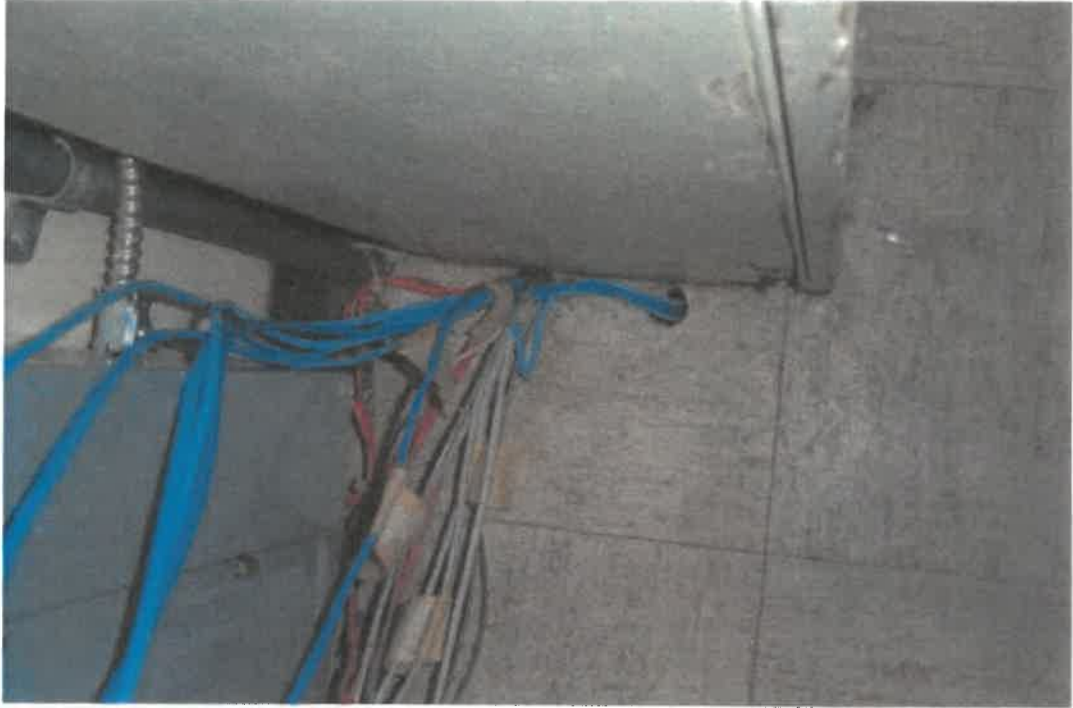
The only issues noted on the telecommunications system were some needed fire-stopping and proper ground bonding.

7.1.1. Non-Firestopped Openings – View 2056

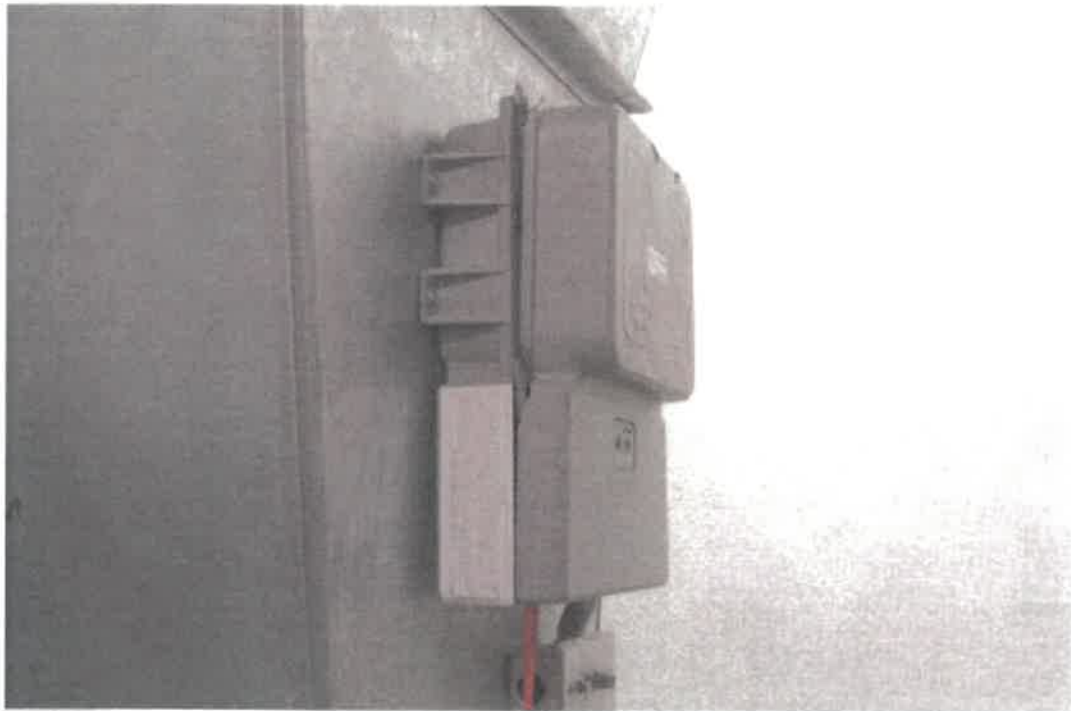
8.2.1. Broken Duct Detector Housing – View 2026-1

8.2.1. The duct smoke detectors housings have recently been replaced with new units, and should give reliable service.
