STRUCTURAL CONDITION ASSESSMENT

NEWTON PUBLIC LIBRARY

720 NORTH OAK

November 2009

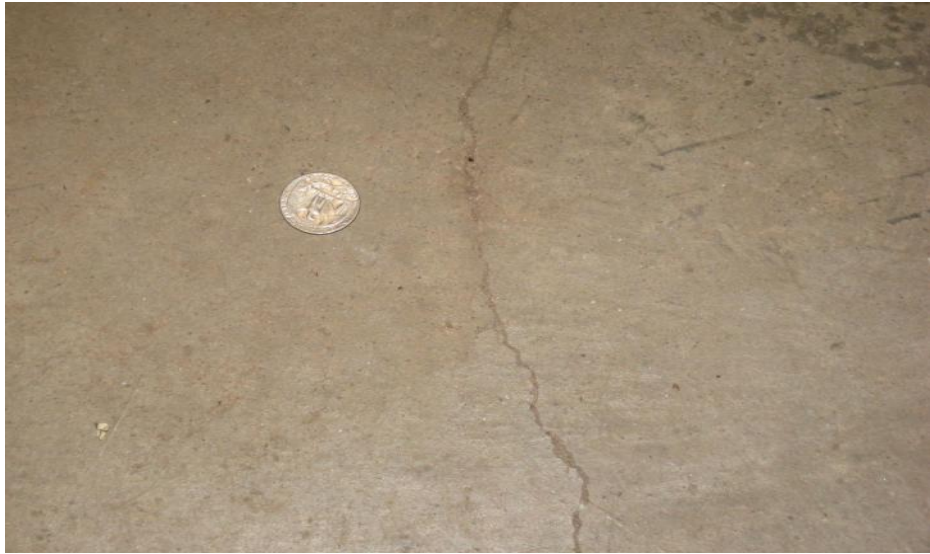
1. The roof and floor framing members have no noticeable sag or deflection and appear to be performing adequately.
2. Some cracking of the floor slab was observed in the basement mechanical rooms. The cracks appear to be old and may be shrinkage cracks from the original slab placement. See Photos 1 and 2. The cracks did not appear to have any vertical offset.

PHOTO 1
SLAB ON GRADE CRACKING AT BASEMENT

14. Monitor the existing basement and retaining wall cracks to determine if the cracks are actively moving or stable and if the cracks allow moisture to enter the wall. Seal the cracks with the appropriate sealant for the crack condition to prevent moisture infiltration. Consult an engineer for additional evaluation if the cracks are found to be actively moving.

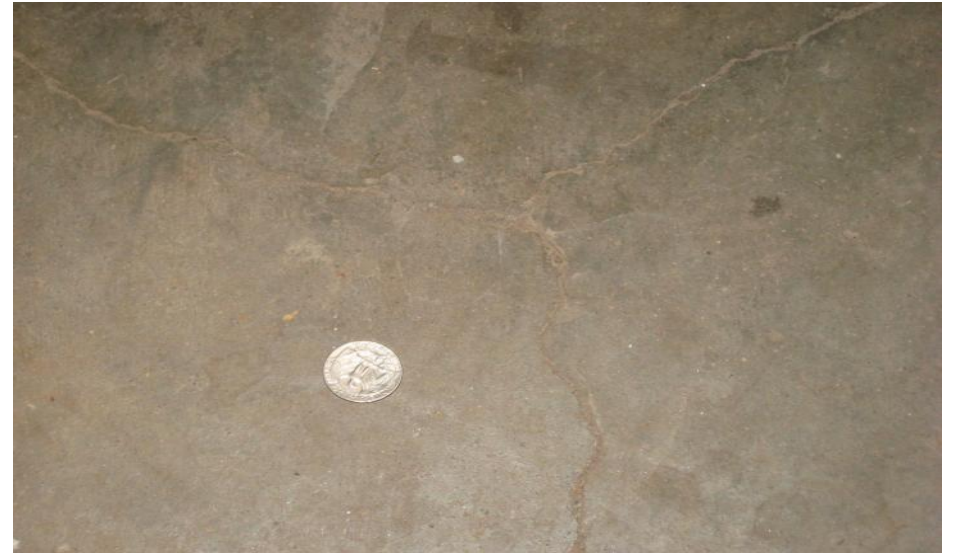
PHOTO 2
SLAB ON GRADE CRACKING AT BASEMENT

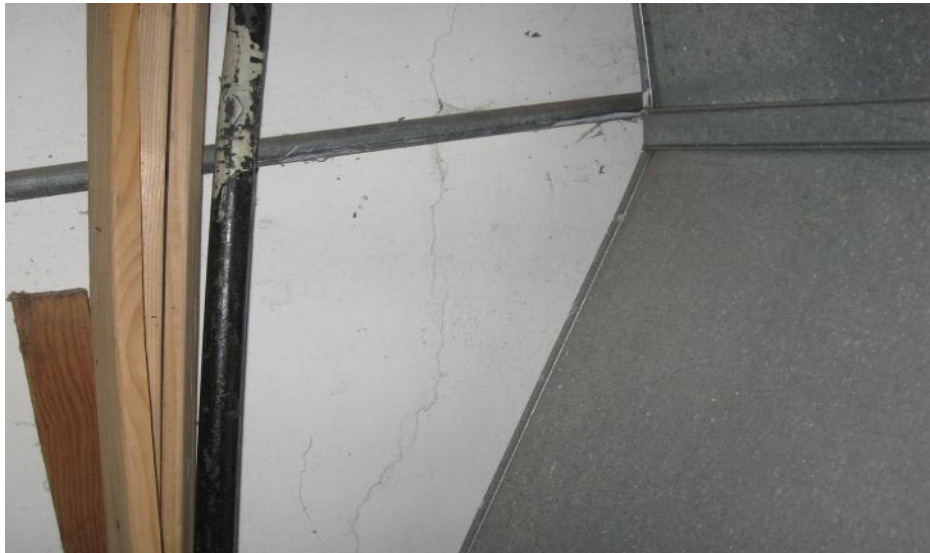
3. Some cracking of the exterior concrete basement walls was observed at the south wall. See Photos 3 and 4. The crack at Photo 3 is near an opening to an exterior area way. These cracks appear to be newer than the paint on the wall indicating some movement of the wall since that time. There was no staining around the crack that might indicate moisture infiltration.

PHOTO 3
BASEMENT WALL CRACKING NEAR AN AREAWAY OPENING

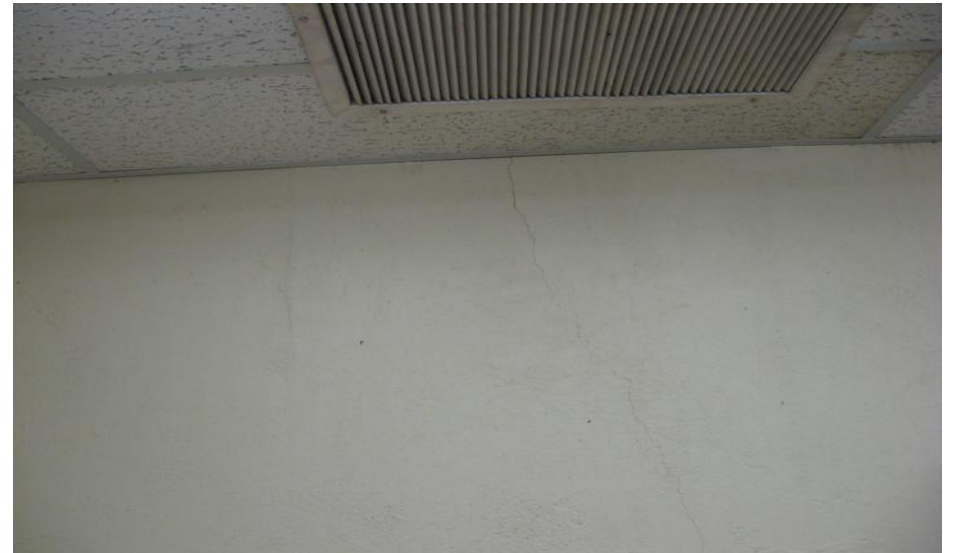
PHOTO 4
BASEMENT WALL CRACKING NEAR AN AREAWAY OPENING

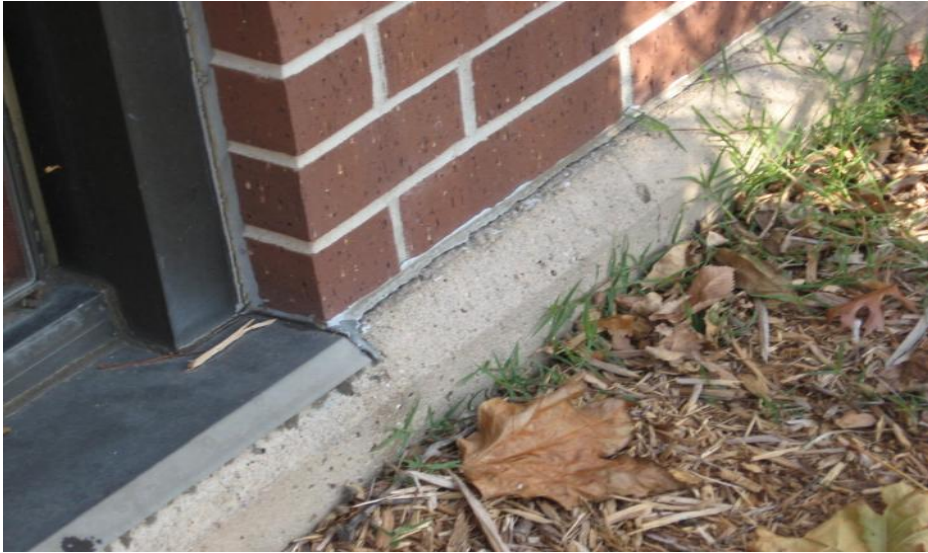
5. There are a number of open masonry joints in the exterior walls. Open horizontal joints occur at the top and bottom of the brick infill walls and open vertical joints occur between the brick walls and cast-in-place concrete columns. See Photos 6, 8, 9, 10, 11, 12, 13, and 14. These joints allow water access to the walls. Moisture within the wall can freeze and the repetitive freeze and thaw action will cause the masonry to crack. Additional cracks will allow additional moisture to enter the wall and will result in an increasing rate of masonry deterioration. Additionally, the moisture may be finding a pathway to the basement area or the moisture may collect at the first floor slab. The open joints should be rehabilitated and properly sealed.

PHOTO 5
WINDOW FLASHING/MASONRY JOINT FAILURE

4. Significant areas of the existing masonry walls require new joint sealants where abutting concrete columns, beams, or precast concrete elements.
5. The detail at the first floor double tee bearing at the north and south walls should be investigated for leakage. A waterproofing system should be considered to protect the joints between building materials where possible leaks can occur.

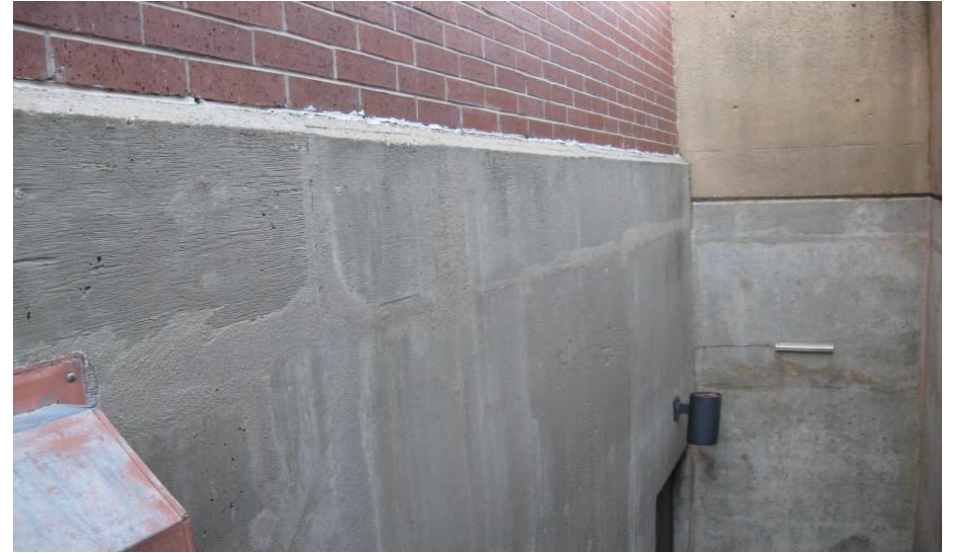
PHOTO 6
**NORTH AREAWAY CONSTRUCTION JOINT AT
DOUBLE TEE BEARING**

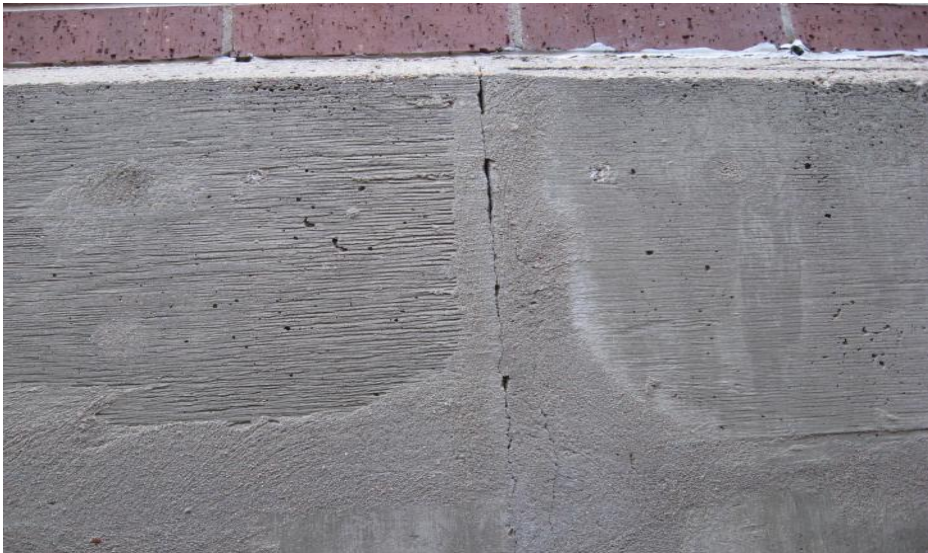
6. Some cracking of the exterior concrete sill was observed. See Photos 7, 8, and 15. These cracks may allow water to enter the wall. The water entering the wall must exit at another location and this can be on the inside or outside of the building. Moisture within the wall can freeze and the repetitive freeze and thaw action will cause the concrete cracks to expand. Additional cracks will allow additional moisture to enter the wall and may result in an increasing rate of concrete deterioration.

PHOTO 7
CRACKED AND OPENED CONSTRUCTION JOINT

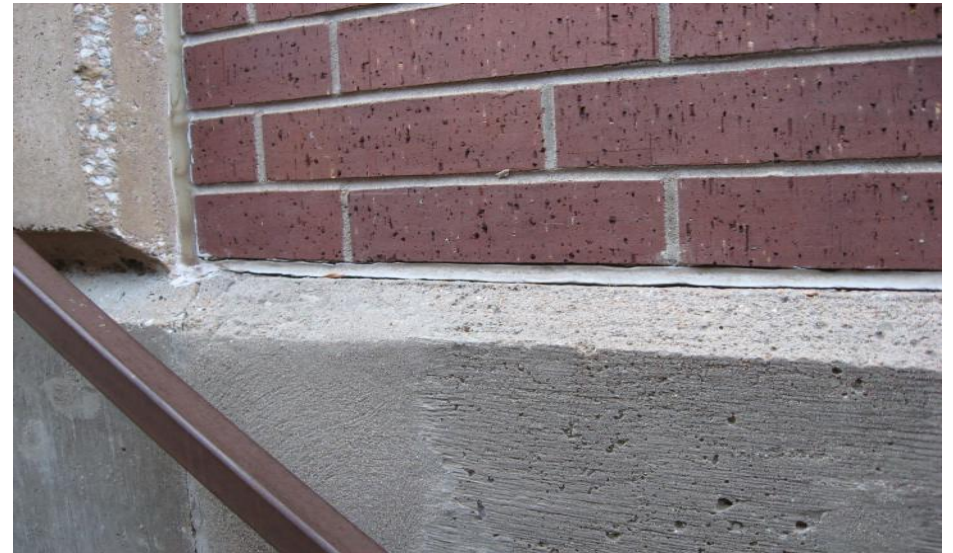
PHOTO 8
SEALANT FAILURE AT BOTTOM OF BRICK

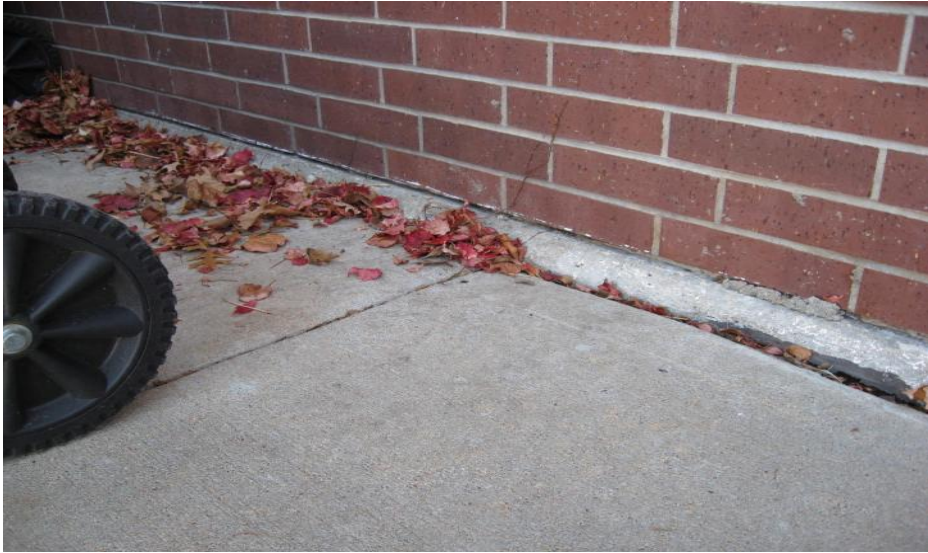
8. Several slabs adjacent to the building or the area way wall have open joints that can allow water to enter the joints. See Photos 9, 17, 18, and 19. Water in the joint can freeze and the repetitive freeze and thaw action will cause the slab joints to expand and potentially move the slab away from the building. Additionally, water may pass through the joint and could find a pathway into the basement. Some of the joints have plant material growing in them. The joints should be cleaned out and properly sealed to prevent moisture infiltration.

PHOTO 9
OPEN SLAB JOINT - RAKED MASONRY BED JOINT

6. Flashing details at the sill of the windows should be reviewed and improved to prevent water from leaking into the building.
7. Sidewalk joints adjacent to the building should be sealed and maintained to prevent water from entering the joints and migrating to other areas.

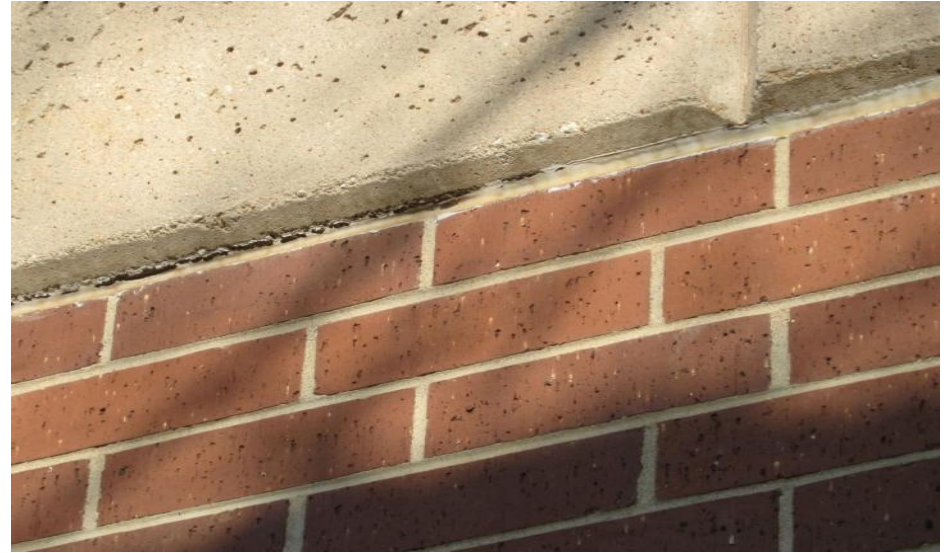
PHOTO 10
SEALANT FAILURE (MASONRY TO SPANDREL BEAM)

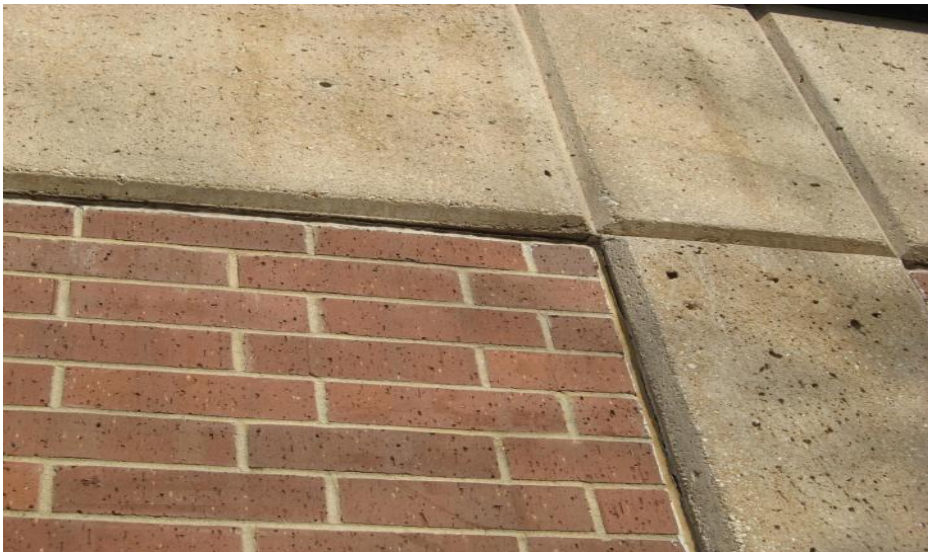
PHOTO 11
SEALANT FAILURE (MASONRY TO CONCRETE COLUMN)

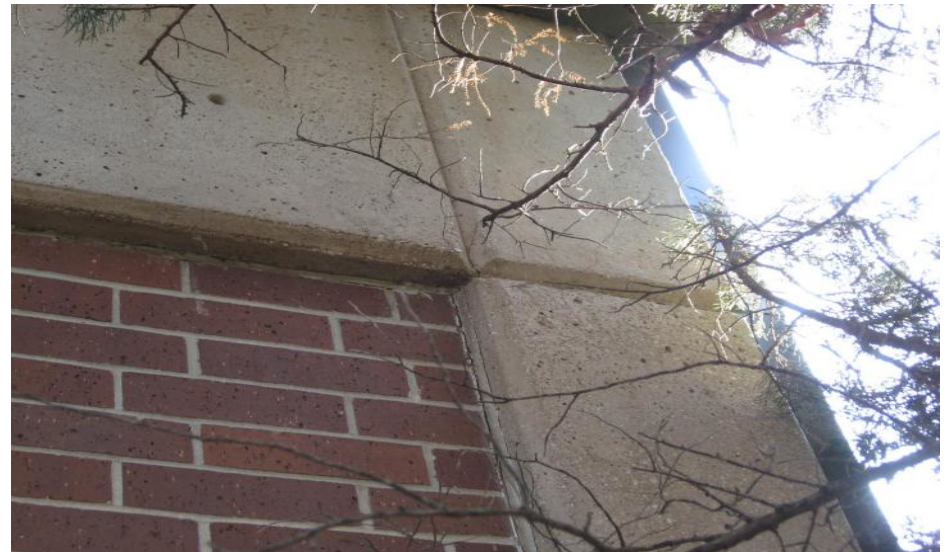
PHOTO 12
SEALANT FAILURE
BRICK TO COLUMN AND BRICK TO SPANDREL

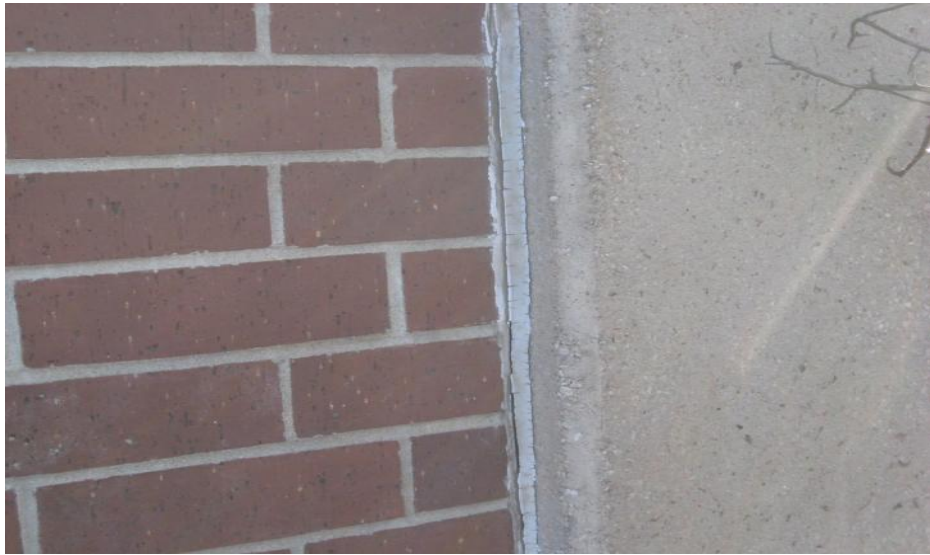
**PHOTO 13
SEALANT FAILURE
BRICK TO COLUMN**

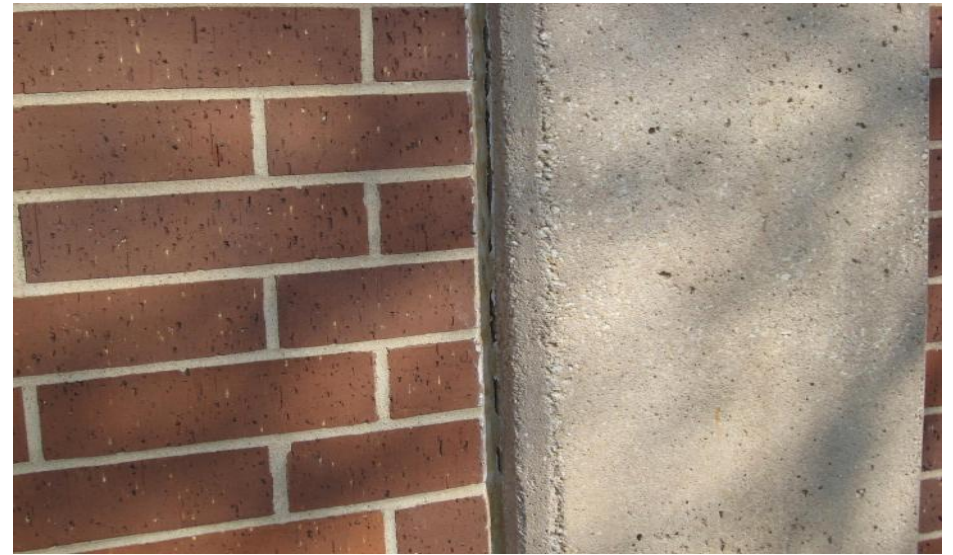
**PHOTO 14
SEALANT FAILURE
MASONRY TO CONCRETE COLUMN**

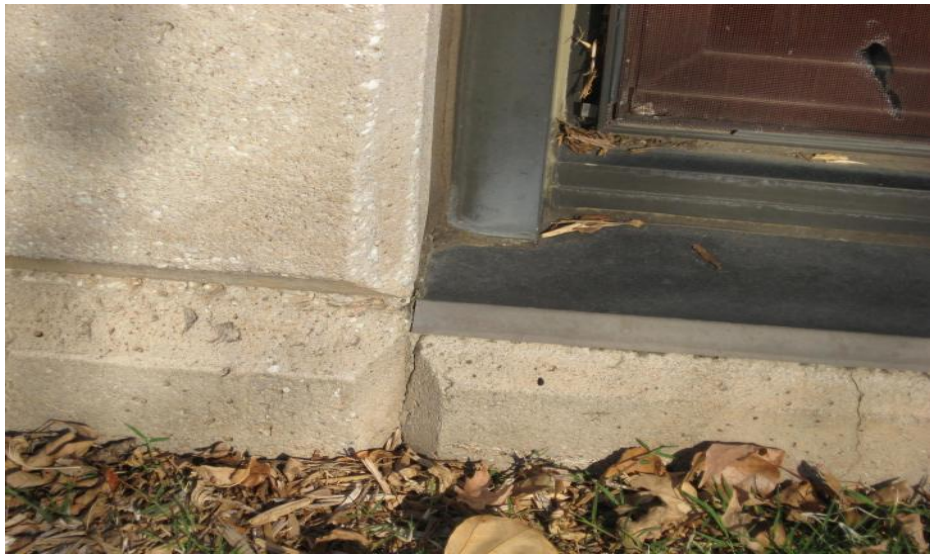
**PHOTO 15
WINDOW FLASHING
CRACKED CONCRETE SILL**

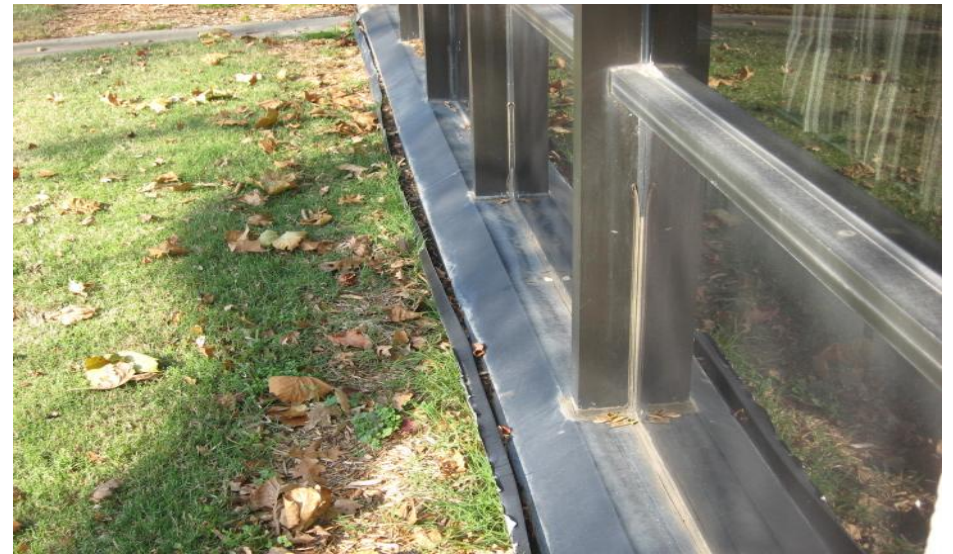
7. A window flashing at the south side of the building has been reworked to include a gutter that directs water to the splash block at the north end of the window. The gutter is full of leaves and has been repeatedly hit by mowing equipment so that it may not function as designed. See Photo 16. Improved window flashing details should be installed to replace the gutter system.

**PHOTO 16
MODIFIED WINDOW FLASHING WITH
GUTTER TO SPLASH BLOCK**

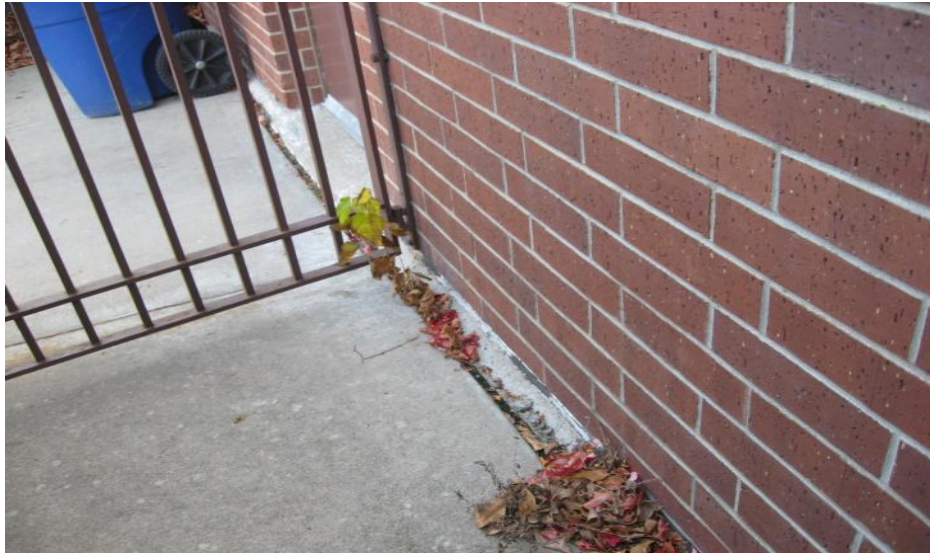
PHOTO 17
PLANT GROWTH IN OPEN SLAB JOINT

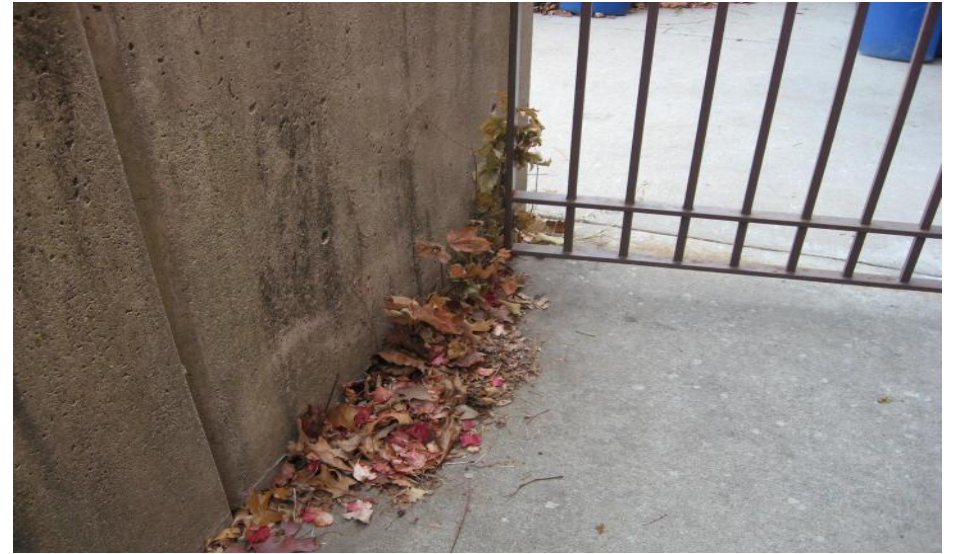
PHOTO 18
PLANT GROWTH IN OPEN SLAB JOINT

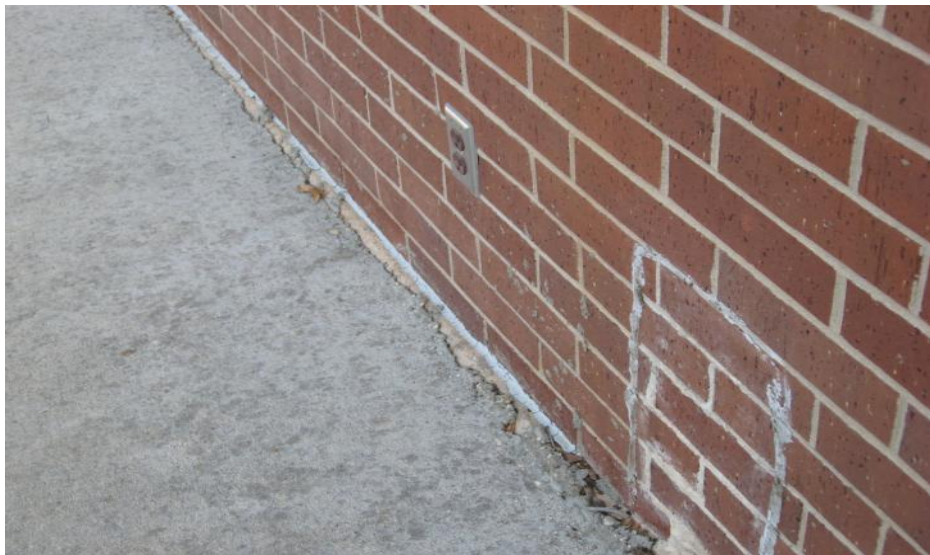
PHOTO 19
POOR SIDEWALK JOINT TO PRECAST

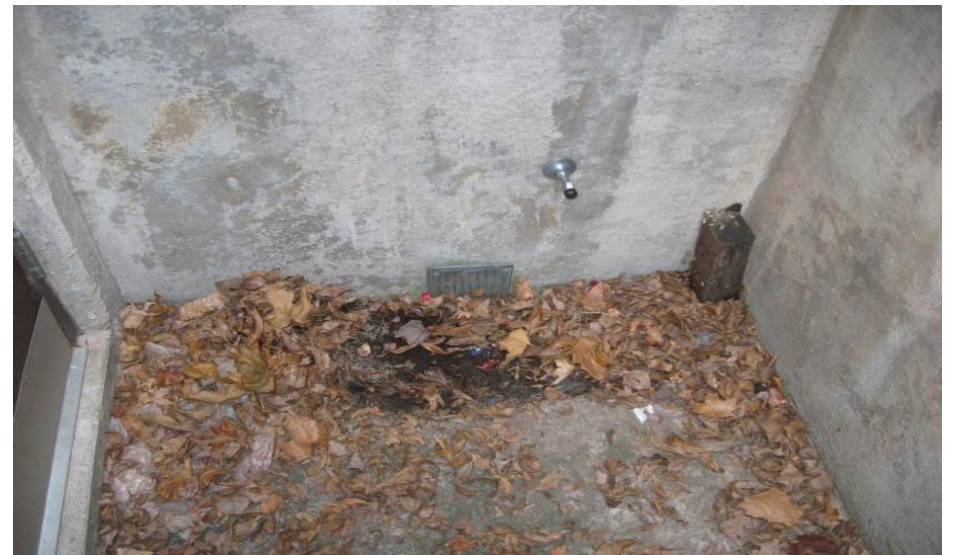
9. Leafs at the bottom of the stair area way can potentially block the area way drain resulting in flooding of the basement through the adjacent door. See Photo 20. Clean the area way of foreign materials to prevent drain blockage.

PHOTO 20
BOTTOM OF AREAWAY - POTENTIAL FOR BLOCKED DRAIN

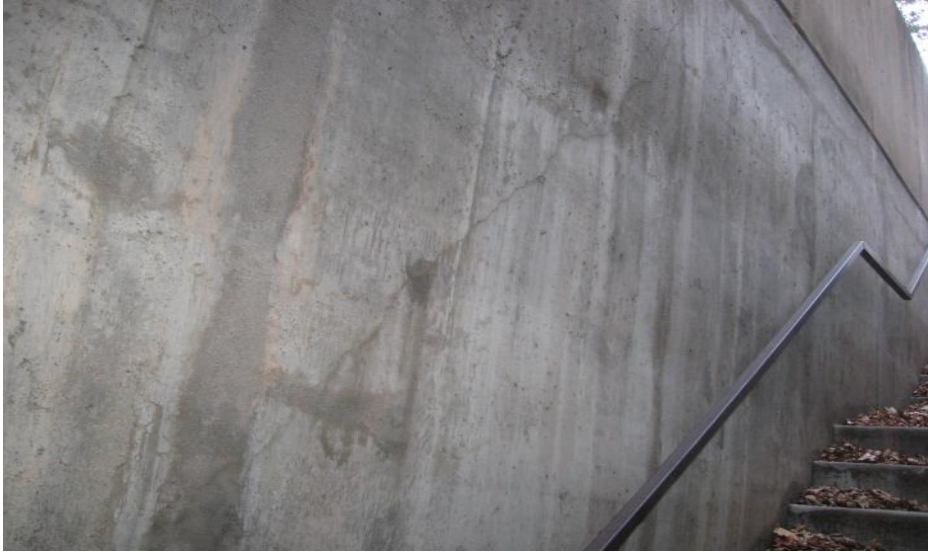
10. There is a diagonal crack in the south retaining wall of the exterior stair. See Photo 21. The crack appears to be tight at this point in time. Monitor the crack for a worsening condition and consider repairs if the crack worsens.

PHOTO 21
CRACKED WALL AT EXTERIOR STAIR

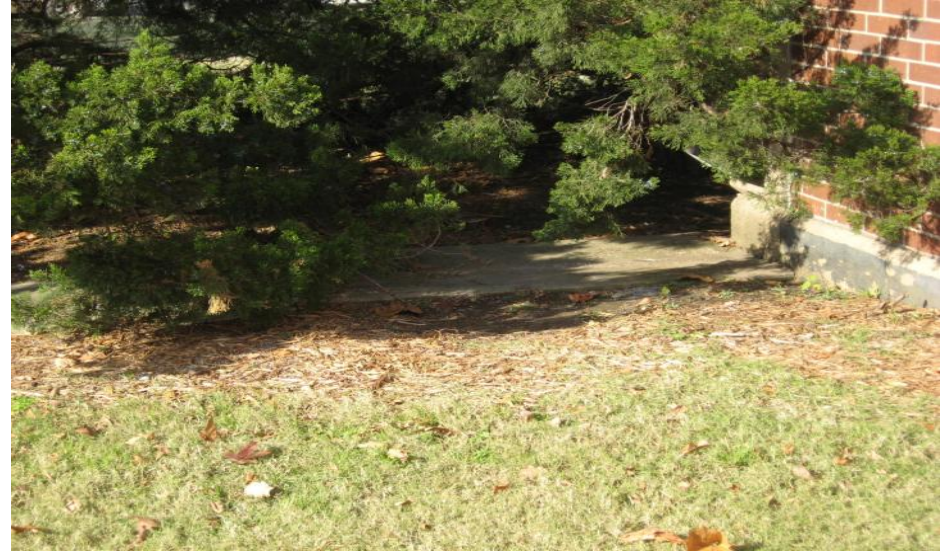
11. Site drainage away from the building is poor. The splash blocks at the downspouts lack adequate slope to direct water away from the building. See Photo 22. There is evidence of water collecting adjacent to the splash block. Re-grade the perimeter of the building to provide good drainage. Common recommendations are for a 5 percent slope for the first 10 feet from the building except where handicap accessibility is required.

PHOTO 22
SPLASH BLOCK DRAINS TO BUILDING

8. Exterior site drainage should be reviewed and improved to provide positive drainage away from the building. Do not allow water to pond adjacent to the building.

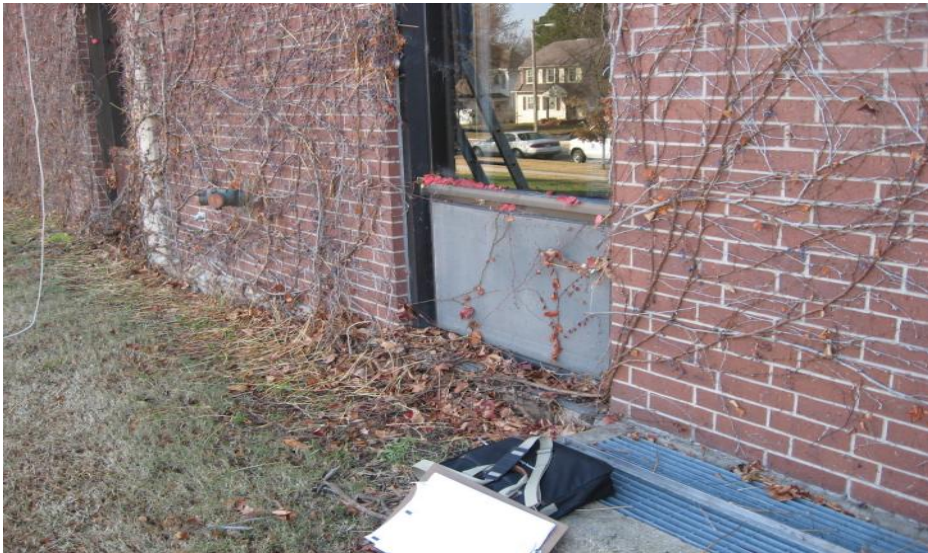
12. There is a climbing vine at the northeast corner of the building that is attached to the wall. See Photo 23. The vine roots in any crack or crevice it can find and then grows to fill any voids. This allows moisture to enter the wall and potentially begin the freeze thaw action that can result in deterioration of the building materials. Remove all vegetation from the exterior walls and repair any damage to the wall and joint sealants.

PHOTO 23
VINES ON BUILDING

11. The existing brick window sills should be repointed.
12. Remove all vegetation from the exterior masonry walls and repoint the masonry where damage is found.

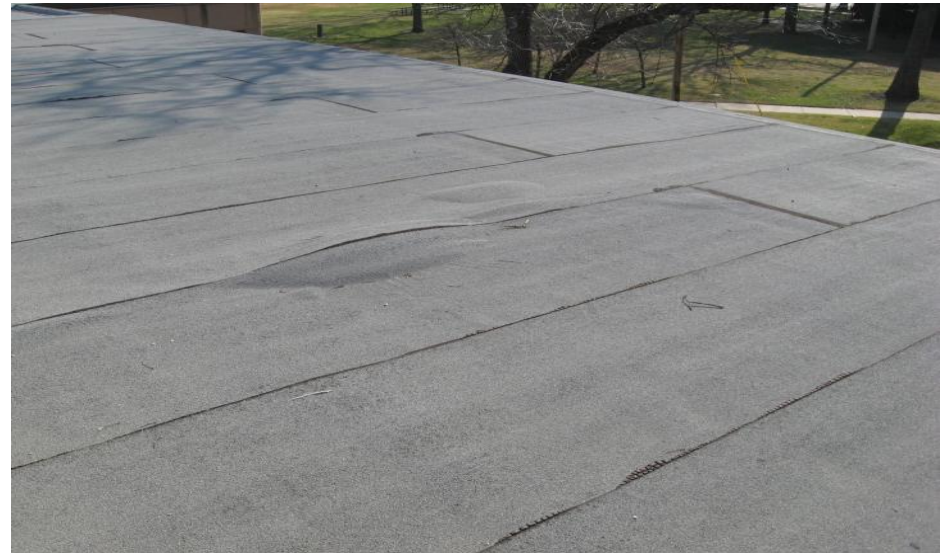
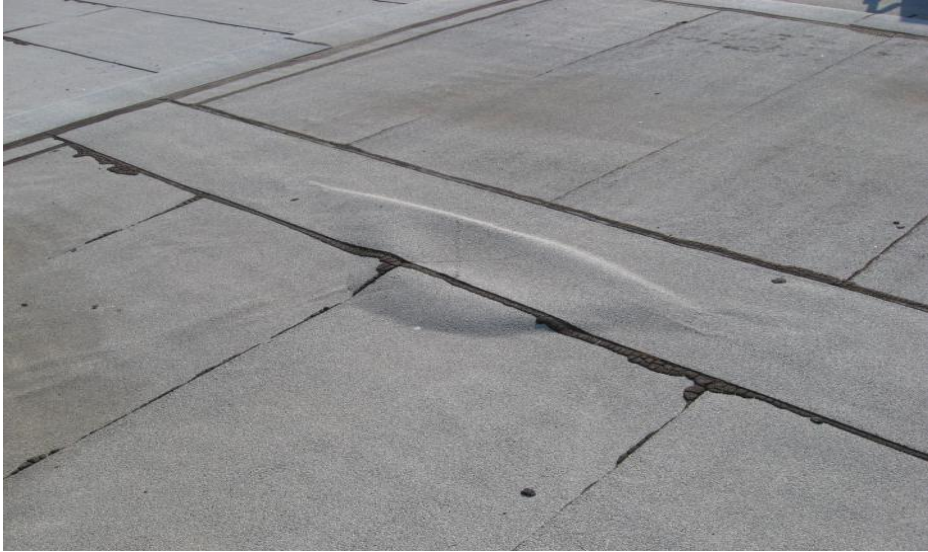
13. The roof membrane is a modified bitumen material and there are a number of bubbles in the system. See Photos 24 and 25. Review the roof condition with a qualified waterproofing consultant and repair or replace the roofing as recommended.

PHOTO 24
BUBBLED ROOFING

**PHOTO 25
BUBBLED ROOFING**

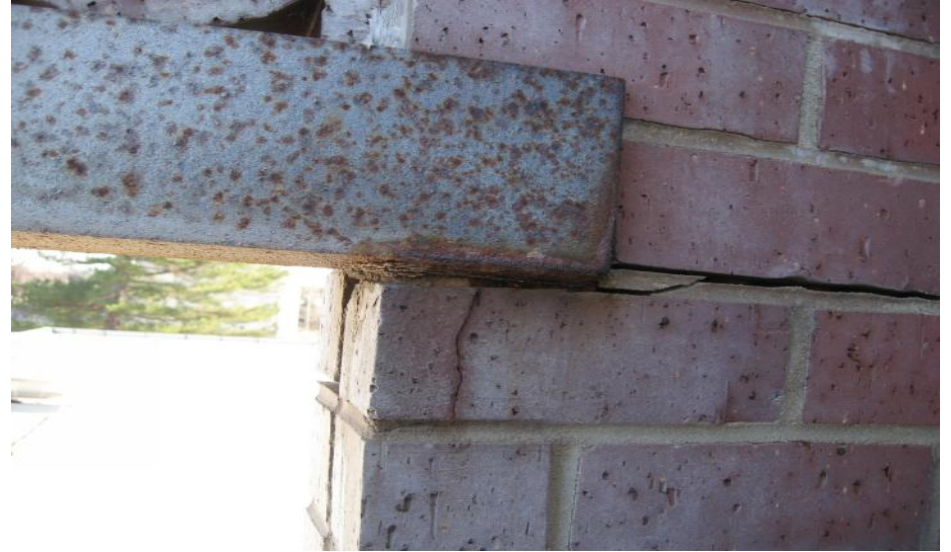
14. There is a masonry screen wall around the cooling tower on the roof. The steel angle lintel above the access opening at the east side is rusted at the south bearing. Rusting is a chemical process that causes the steel to expand. The expansion of the horizontal leg of the angle is large enough to crack the masonry pilaster and fail the bearing below the lintel. See Photo 26. The lifting action caused by the rusting has caused the entire lintel to rotate and has resulted in a long horizontal crack in the joint adjacent to the lintel. See Photo 27. The cracks extend through the joint to the outside face of the masonry. See Photos 28 and 29. Replace the rusted lintel with a new lintel that is hot dip galvanized and avoid damaging the galvanizing during installation. Repair the adjacent masonry.

**PHOTO 26
RUSTED LINTEL BEARING AND JOINT EXPANSION**

9. Replace the angle lintel at the roof mechanical screen opening with a new hot dip galvanized lintel angle. Repair the masonry at the lintel bearing and above and adjacent to the lintel.

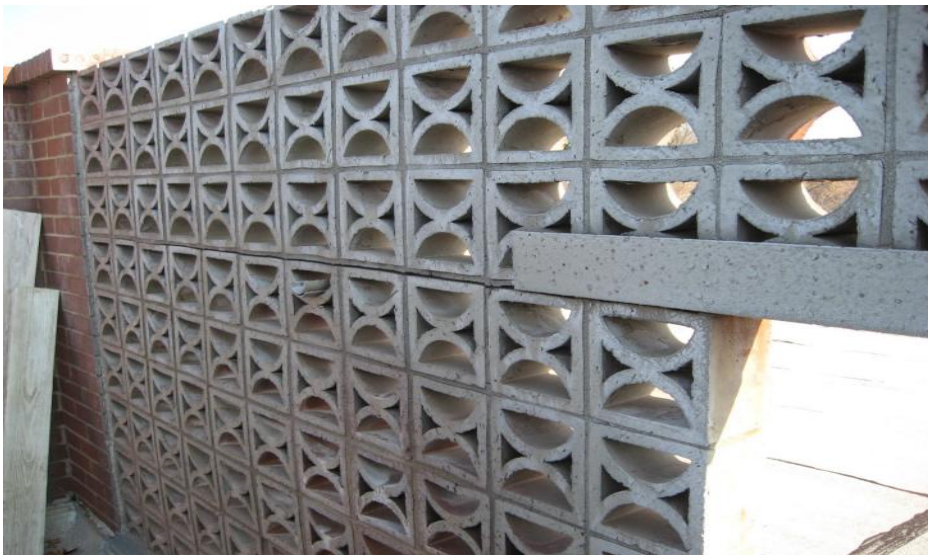
**PHOTO 27
CRACKED MASONRY DUE TO LINTEL ROTATION**

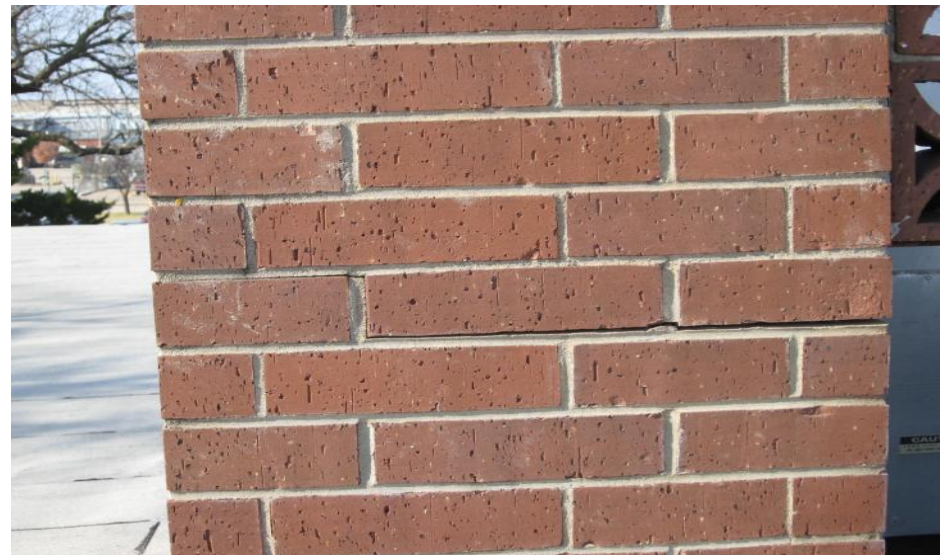
**PHOTO 28
CRACKED PILASTER JOINT**

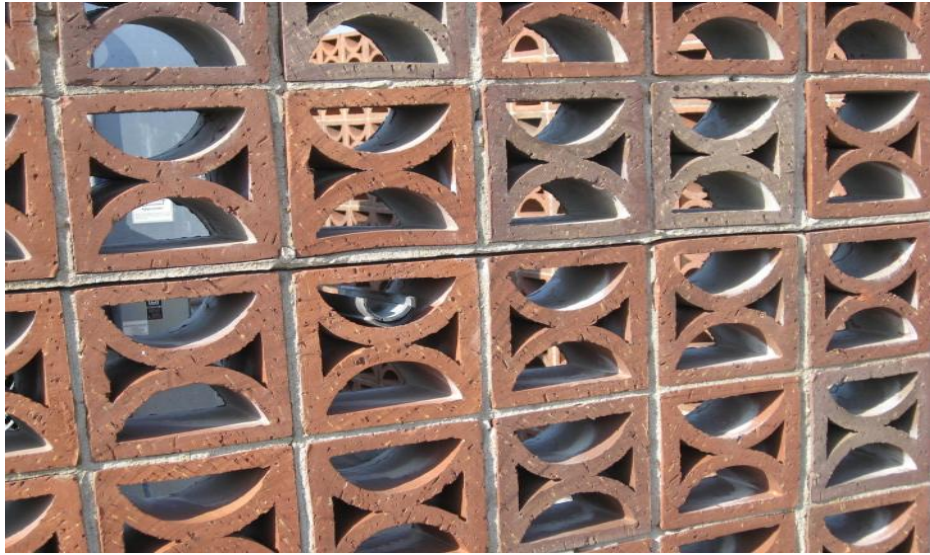
**PHOTO 29
CRACKED MORTAR JOINT**

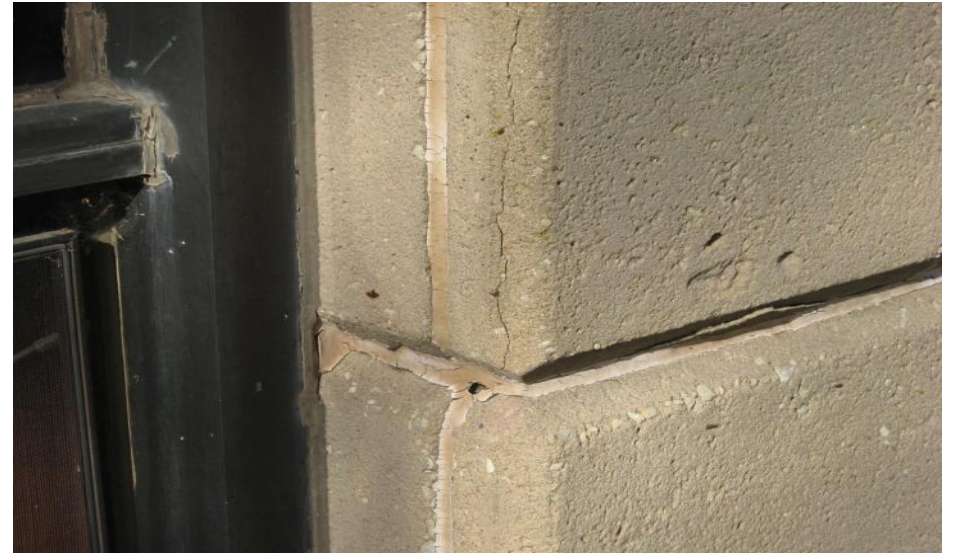
18. The exterior precast concrete veneer is weathered and shows signs of deterioration. There are a number of cracks in the sides and surface of the precast units. See Photos 30, 31, and 32. These cracks may allow water to enter the precast unit. Moisture within the precast unit can freeze and the repetitive freeze and thaw action will cause the concrete cracks to expand. Additional cracks will allow additional moisture to enter the wall and may result in an increasing rate of concrete deterioration.

20. Many of the sealant joints around the precast units are cracked and leaking. See Photos 30, 31, 34, 35, and 36. Failure of the sealant allows water to enter the wall. The water entering the wall must exit at another location and this can be on the inside or outside of the building. Moisture within the wall can freeze and the repetitive freeze and thaw action may result in movement and/or cracking of the precast veneer or the masonry backup. Several of the lower precast vertical units appear to be pushed out away from the building. See Photos 34 and 36. This may be indicative of a possible connection failure within the wall system.

**PHOTO 30
CRACKED PRECAST VENEER AT ADDITION
AND SEALANT FAILURE**

13. Review the condition of the exterior precast units at the building addition for possible repair or replacement based on the most economical long term solution.

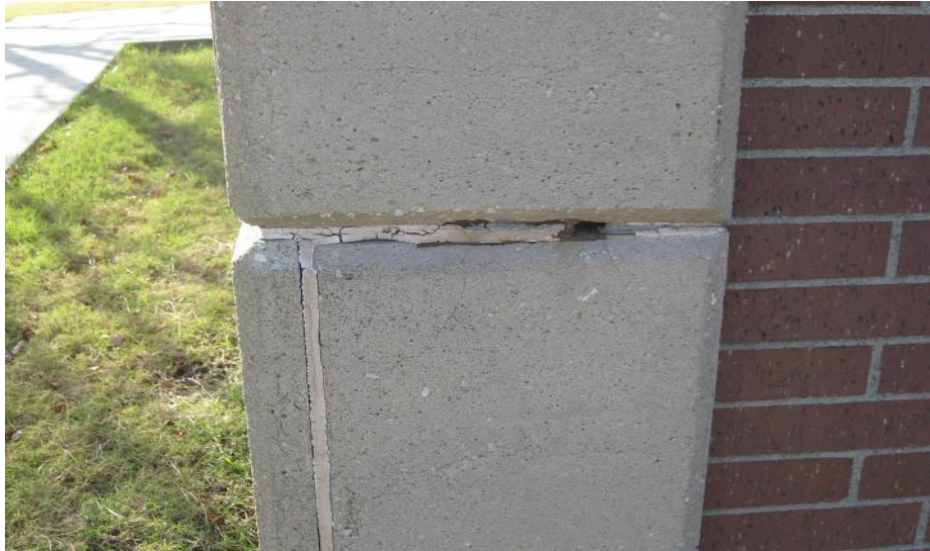
19. Some of the precast units have exposed reinforcing or connection elements that are rusting. See Photos 31 and 33. The rusting action results in expansive forces that will induce forces within the concrete that result in cracks. The cracks may allow water to enter the precast unit and set up the freeze thaw action that results in material degradation.

**PHOTO 31
CRACKED PRECAST VENEER AT ADDITION
AND SEALANT FAILURE**

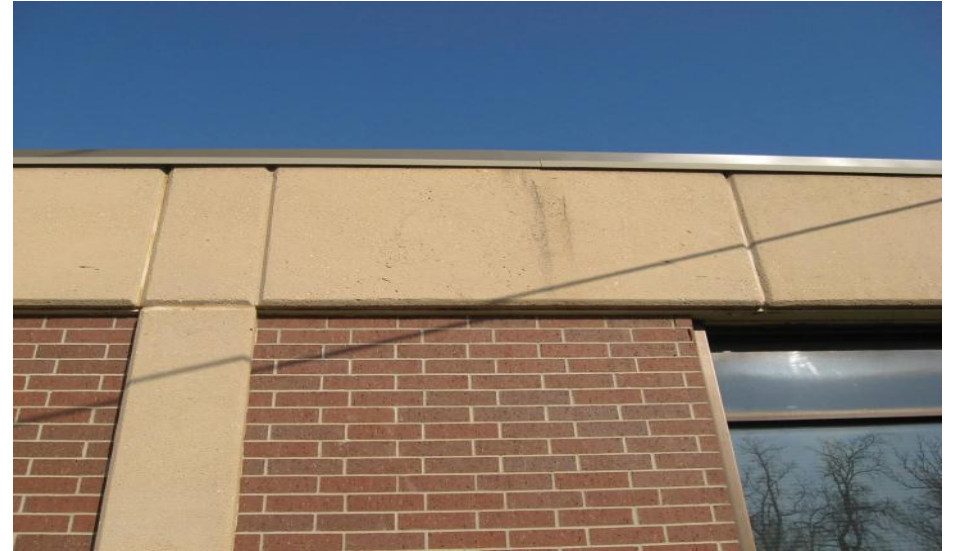
**PHOTO 32
STAINING OF PRECAST VENEER AT CONCRETE CRACK
LOCATIONS**

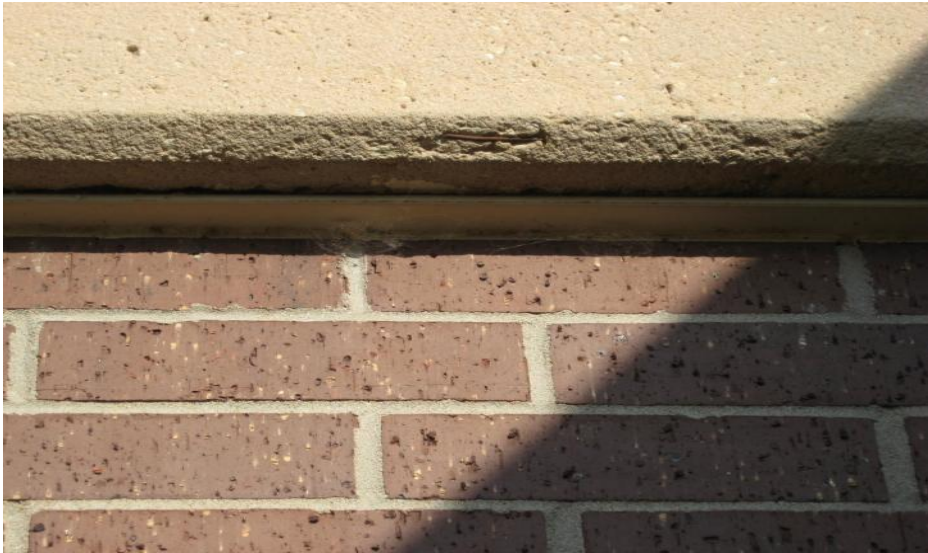
PHOTO 33
EXPOSED AND RUSTING STEEL IN PRECAST VENEER

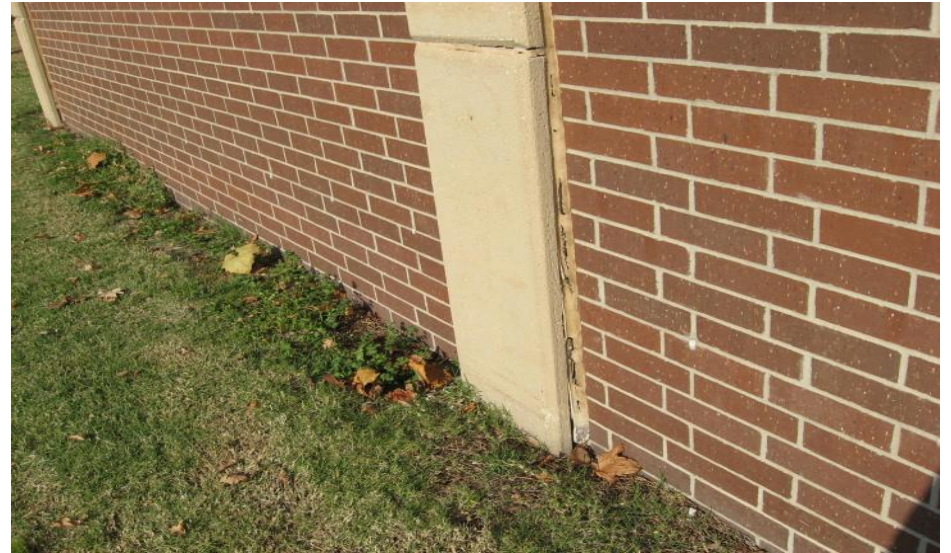
27. The existing site drainage is poor. See Photos 34 and 43. There is evidence of water collecting in a low spot at the south east corner of the addition. The soil adjacent to the south wall appears to slope towards the building. Re-grade the perimeter of the building to provide good drainage.

PHOTO 34
POSSIBLE PRECAST VENEER CONNECTION FAILURE

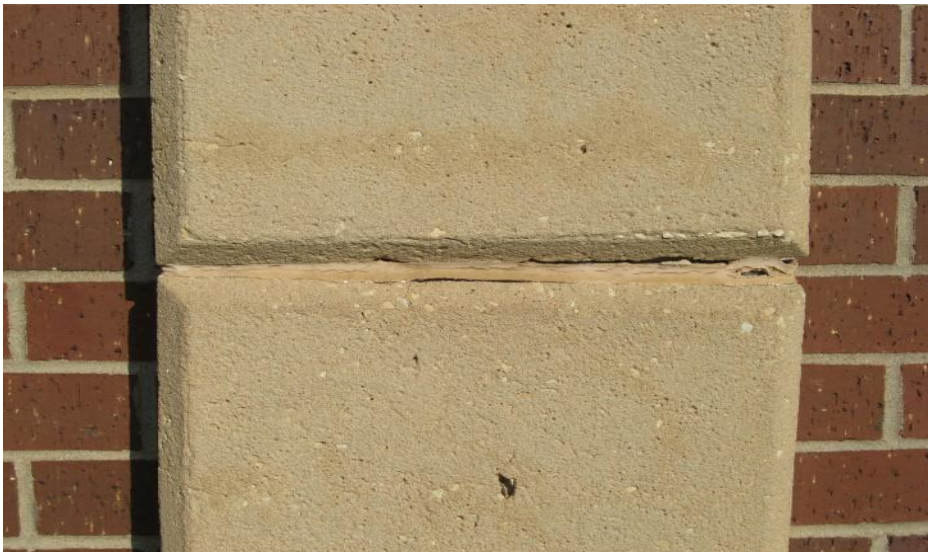
PHOTO 35
SEALANT FAILURE AT PRECAST VENEER

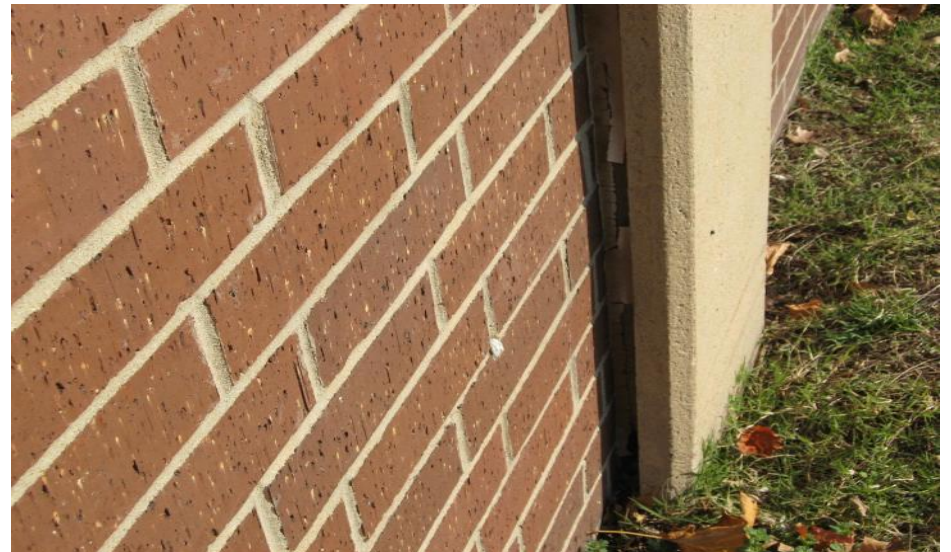
PHOTO 36
POSSIBLE PRECAST VENEER CONNECTION FAILURE

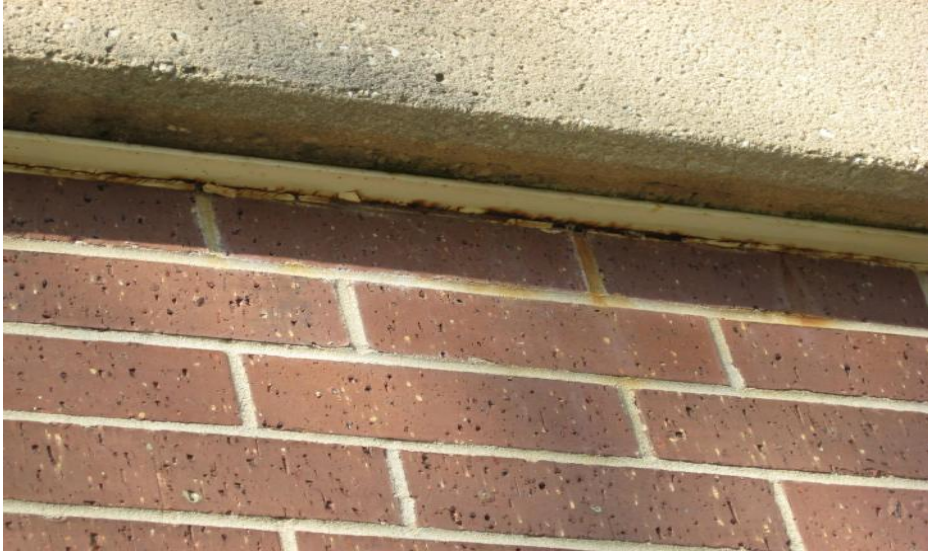
21. A continuous steel angle is being used to support the horizontal precast veneer at the top of the exterior wall. The steel angle is rusting and the rust is staining the brick. See Photo 37. There is no drip designed in the bottom surface of the precast. Water runs down the face of the precast and returns the corner to the steel lintel.

PHOTO 37
RUSTING VENEER LINTEL (NO DRIP ON PRECAST VENEER)

10. Remove the rust from the perimeter precast support angle at the perimeter of the building addition and provide a long lasting protective coating. Place a drip edge at the bottom of the precast to prevent water from traveling along the bottom of the precast and into the lintel or the joint below the lintel.

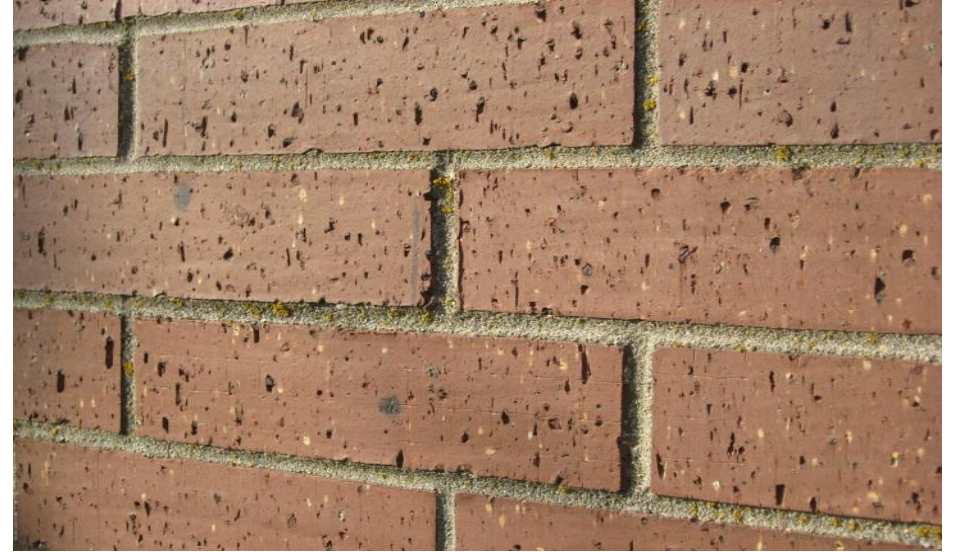
22. The exterior brick at the east wall has mold or fungi growing on the mortar joints. See Photo 38. This may hold water and result in potential deterioration of the mortar as water is allowed to enter the mortar and begin the freeze thaw action. The masonry should be cleaned and sealed to prevent future growth.

PHOTO 38
MOLD ON BRICK MORTAR SURFACE
