STRUCTURAL CONDITION ASSESSMENT

NEWTON PUBLIC LIBRARY

720 NORTH OAK

November 2009

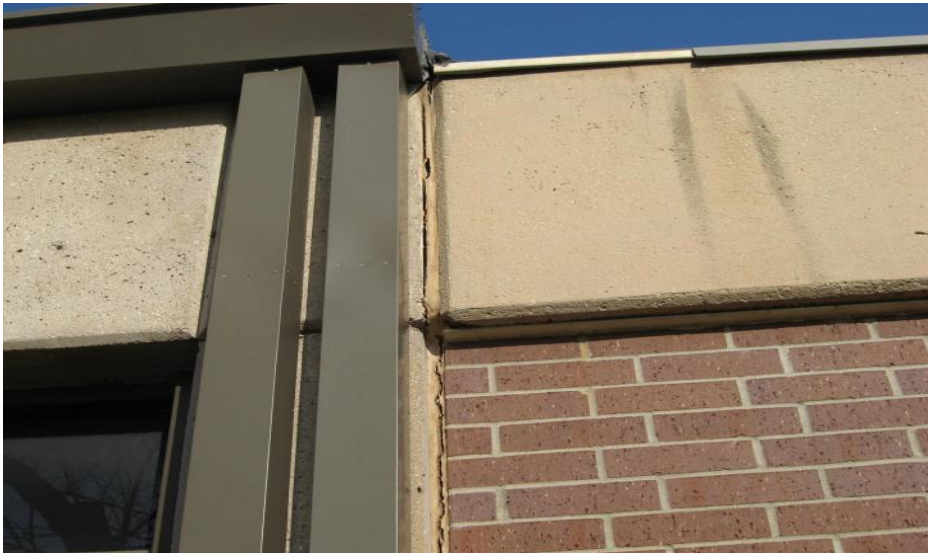
23. The sealant at the joint between the original building and the building addition is cracked and leaking. See Photo 39. The joint design should be reviewed to accommodate building movement and the sealant replaced to prevent moisture and air infiltration.

PHOTO 39
SEALANT FAILURE AT JOINT BETWEEN ORIGINAL BUILDING AND ADDITION

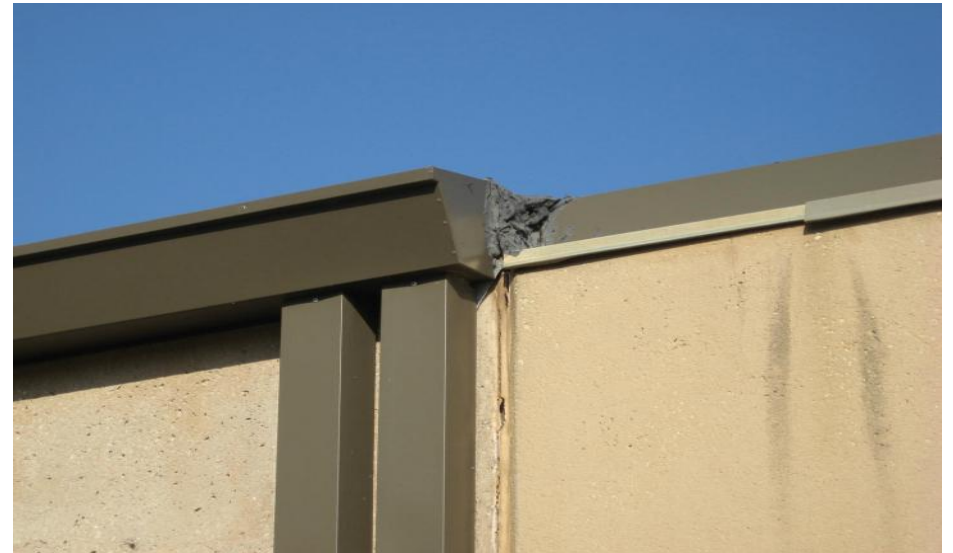
24. The top of wall flashing at the joint between the original building and the addition appears to be terminated with a butt joint. Roofing mastic has been placed over the remaining crack to seal the joint. See Photo 40. A more flexible joint is required at this location due to the differential movement of the different structures. The flashing should be redesigned to accommodate the movement.

PHOTO 40
SEALANT FAILURE AT FLASHING TRANSITION

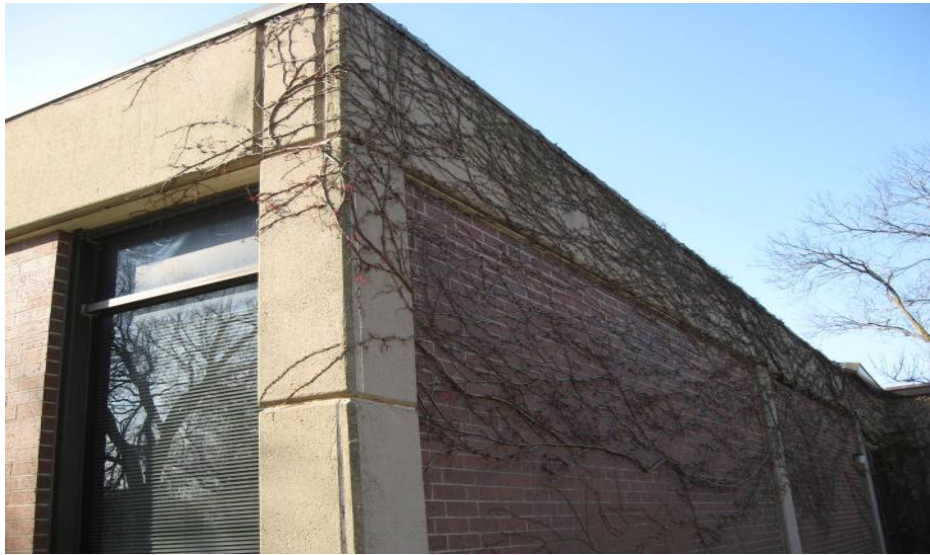
25. There is a climbing vine at the northeast corner of the building addition that is attached to the wall. See Photo 41. The vine roots in any crack or crevice it can find and then grows to fill any voids. This allows moisture to enter the wall and potentially begin the freeze thaw action that can result in deterioration of the building materials. Remove all vegetation from the exterior walls and repair any damage to the wall and joint sealants.

PHOTO 41
VINES ON SIDE OF BUILDING
SOURCE OF MASONRY DETERIORATION

11. The existing brick window sills should be repointed.
12. Remove all vegetation from the exterior masonry walls and repoint the masonry where damage is found.

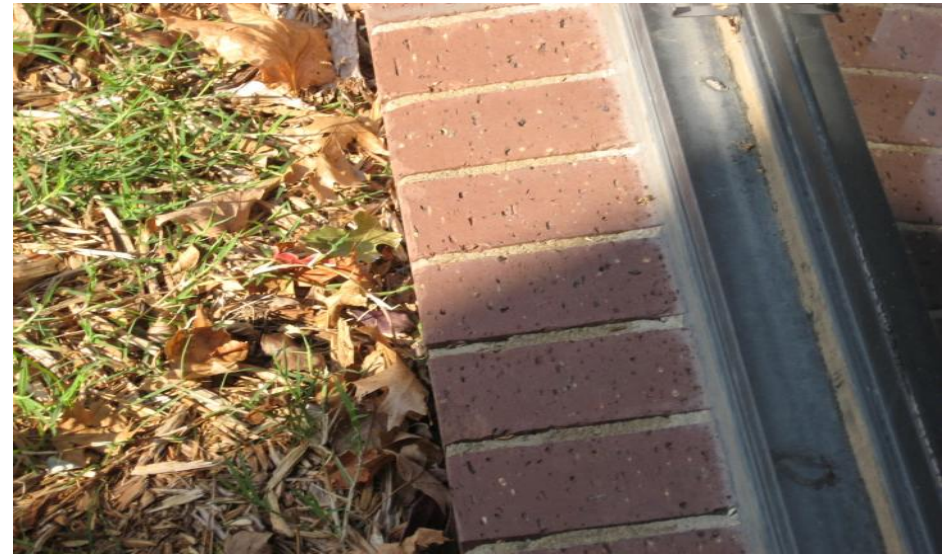
26. Bricks are used to form the window sills and the mortar between bricks is showing signs of deterioration where water, snow, and ice can collect on the horizontal surface. See Photo 42. The damaged joints can be repointed with new mortar.

PHOTO 42
MORTAR DETERIORATION AT WINDOW SILL

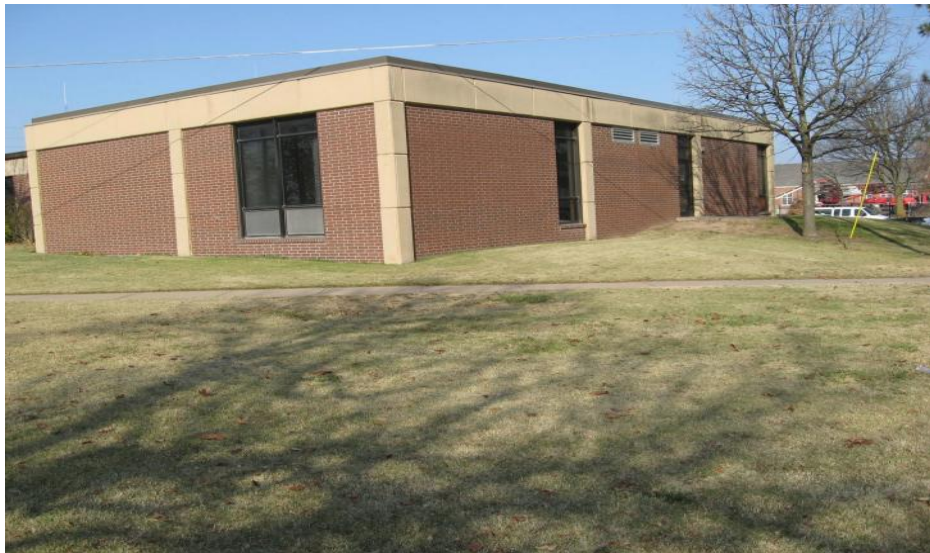
27. The existing site drainage is poor. See Photos 34 and 43. There is evidence of water collecting in a low spot at the south east corner of the addition. The soil adjacent to the south wall appears to slope towards the building. Re-grade the perimeter of the building to provide good drainage.

PHOTO 43
SITE GRADING AT SOUTHEAST BUILDING CORNER

Common recommendations are for a 5 percent slope for the first 10 feet from the building except where handicap accessibility is required.

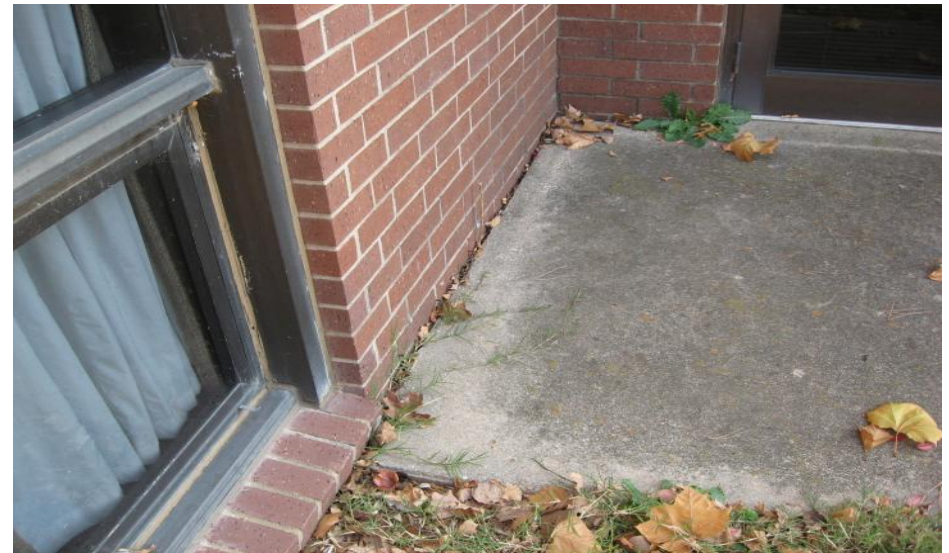
28. Sidewalk pads at the exterior doors have open joints adjacent to the building that can allow water to enter the joints. See Photos 44 and 45. Water in the joint can freeze and the repetitive freeze and thaw action will cause the slab joints to expand and potentially move the slab away from the building. Additionally, water may pass through the joint and could find a pathway to the foundation. Some of the joints have plant material growing in them. The joints should be cleaned out and properly sealed to prevent moisture infiltration.

PHOTO 44
OPEN JOINT AT SIDEWALK SLAB

6. Flashing details at the sill of the windows should be reviewed and improved to prevent water from leaking into the building.
7. Sidewalk joints adjacent to the building should be sealed and maintained to prevent water from entering the joints and migrating to other areas.

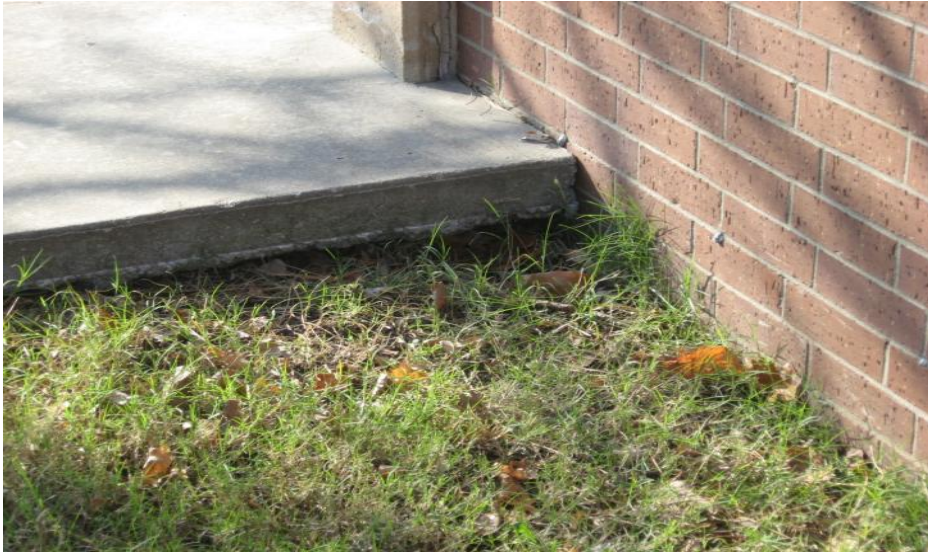
29. The grade adjacent to the east side of the building addition has settled and compromised the bearing for the slab at the exterior door. See Photo 45. Compact new fill in the voids below the slab and adjust the grade at the perimeter of the slab to provide adequate drainage away from the building.

PHOTO 45
SETTLEMENT OF SOILS ADJACENT TO BUILDING
AND BELOW SIDEWALK

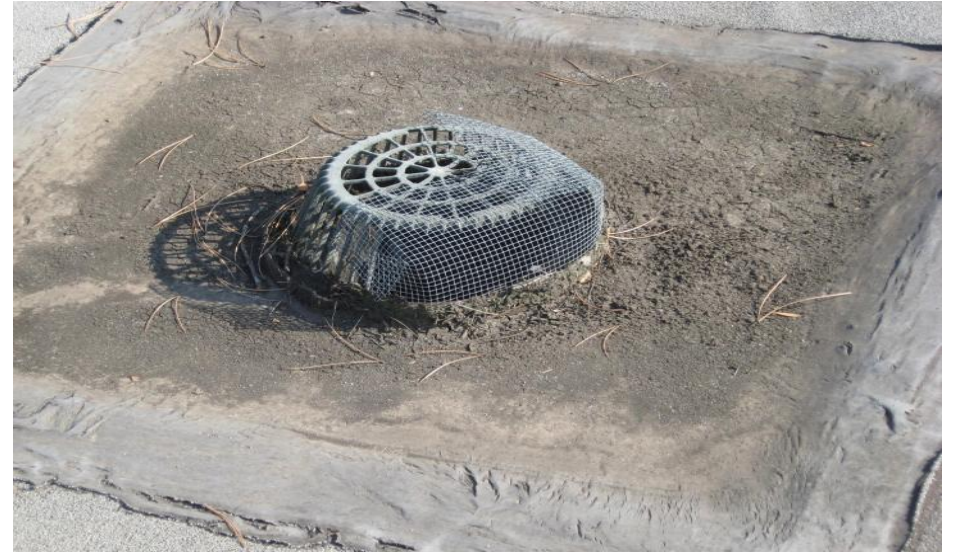
30. Roof drainage at the southeast roof drain is compromised by debris that has built up around a piece of hardware cloth that has been installed to correct a broken roof drain cover. See Photo 46. There is evidence of some ponding around the roof drain. Clear the debris to allow free flow of rain water at the drain. Replacement of the broken roof drain cover is recommended.

PHOTO 46
PARTIALLY BLOCKED AND BROKEN ROOF DRAIN

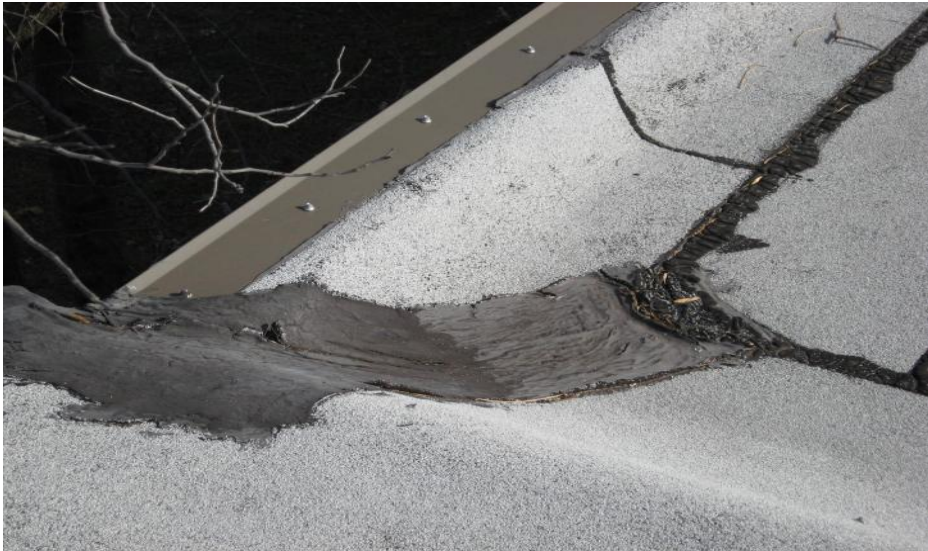
31. A mopped sealant joint where the modified bitumen roofing makes a transition from the original building to the addition has raised edges and poses a potential roof leak. See Photo 47.

PHOTO 47
POTENTIAL ROOF LEAK AT SEALANT

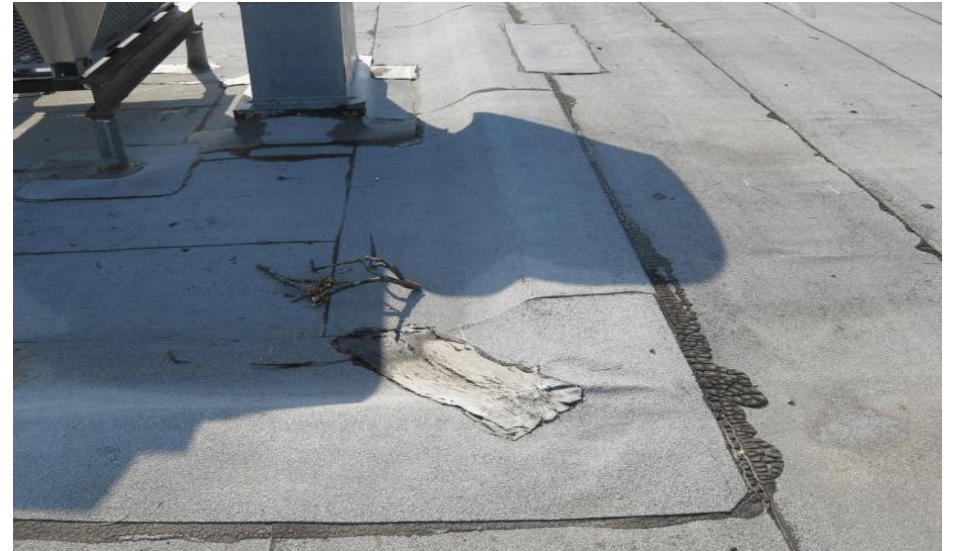
32. The roofing transition from the original building to the building addition consists of a section of the modified bitumen roofing placed over the joint. See Photo 48. The construction drawings for the building addition indicated a roof expansion joint that would allow for differential movement between the original building and the addition. The current roofing does not allow for much movement between the different structures of the original building and the addition. It is likely that the structures of the original building and the building addition will move differently when subjected to wind loads or temperature changes. Even though the roofing appears to be performing satisfactorily today, future differential movement may cause the roofing membrane to tear and result in a leak. Installation of a roof joint that is designed to accommodate building movement is recommended between the original building and the addition.

PHOTO 48
ROOF TRANSITION BETWEEN ORIGINAL BUILDING AND
BUILDING ADDITION
